Brookwillow Village HOA
Building Elevation and Roof Evaluation
2450 1/2 Ajay Avenue
Grand Junction, CO 81505
Client File: 124830-1
Haag File: 12240428CO-1855/254

October 8, 2024

Re: Brookwillow Village HOA
Building Elevation and Roof Evaluation
2450 1/2 Ajay Avenue
Grand Junction, CO 81505
Client File: 124830-1
Haag File: 12240428CO-1855/254

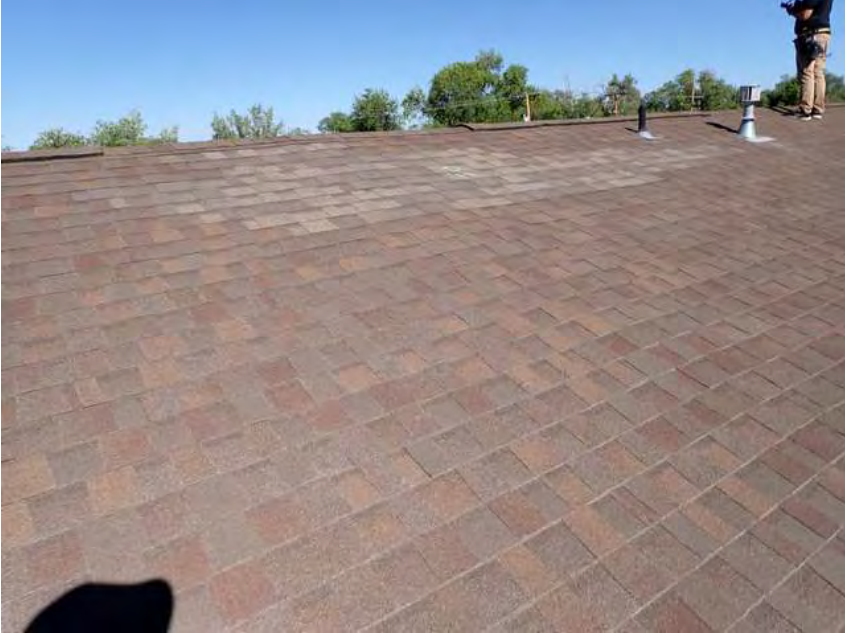
17. Building 1. Repair.

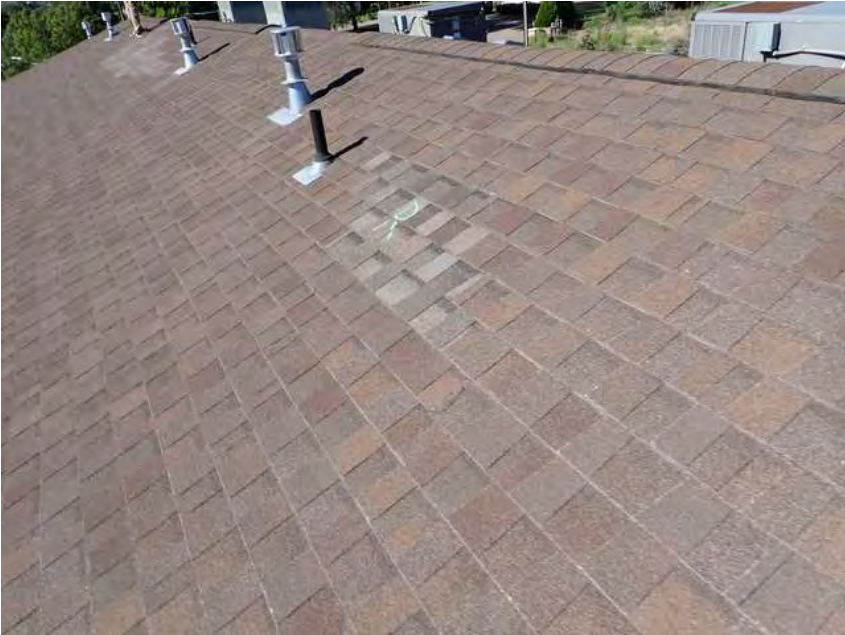
18. Building 1. Repair.

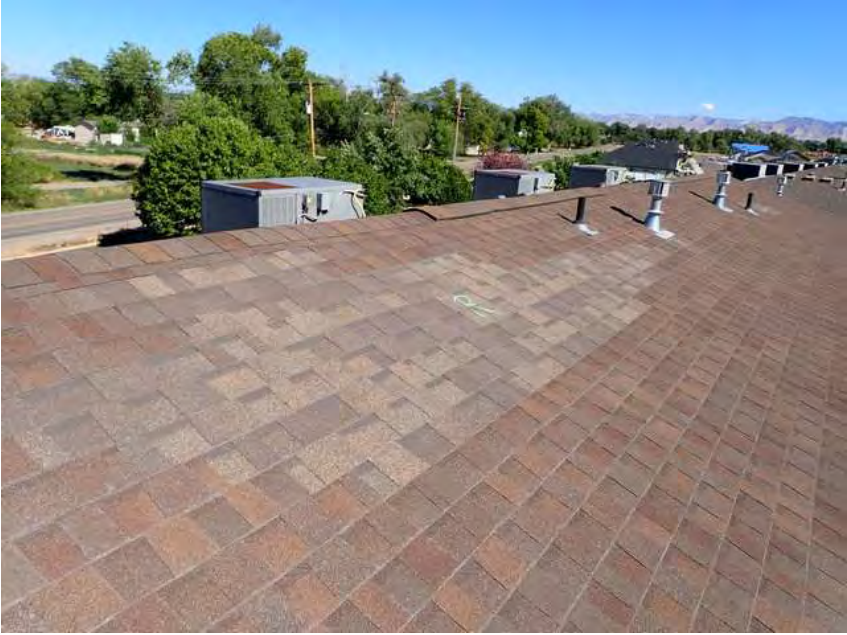
19. Building 1. Repair.

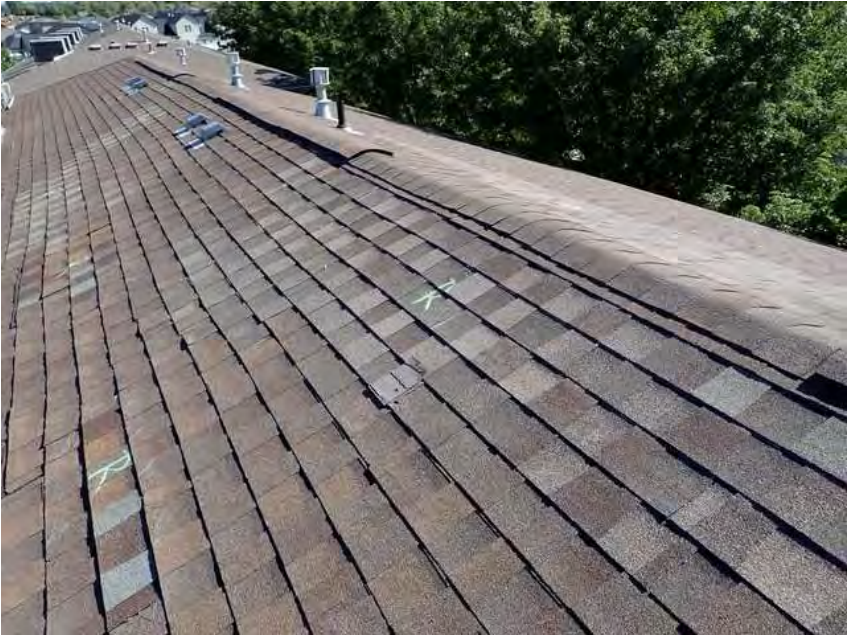
20. Building 1. Multiple repairs.

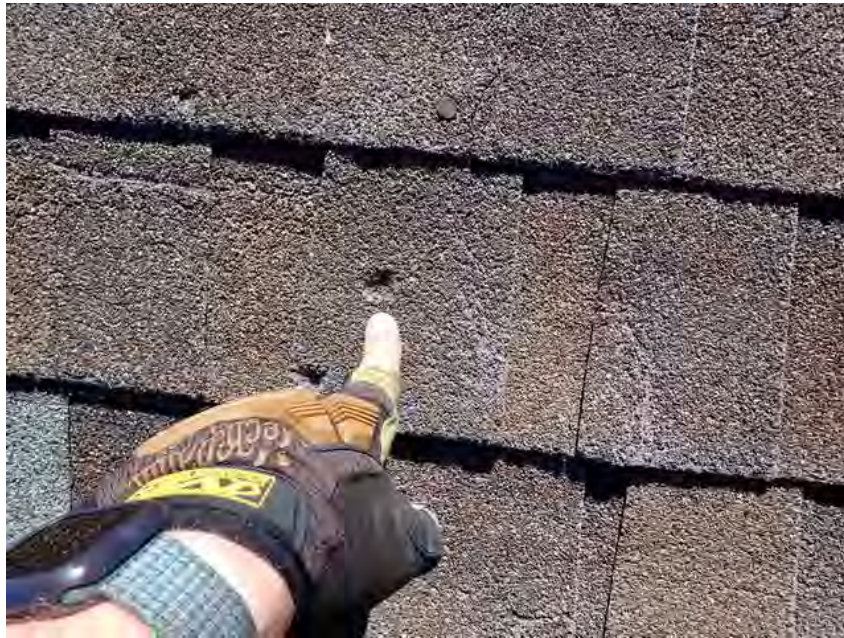
21. Building 1. Puncture in shingle.

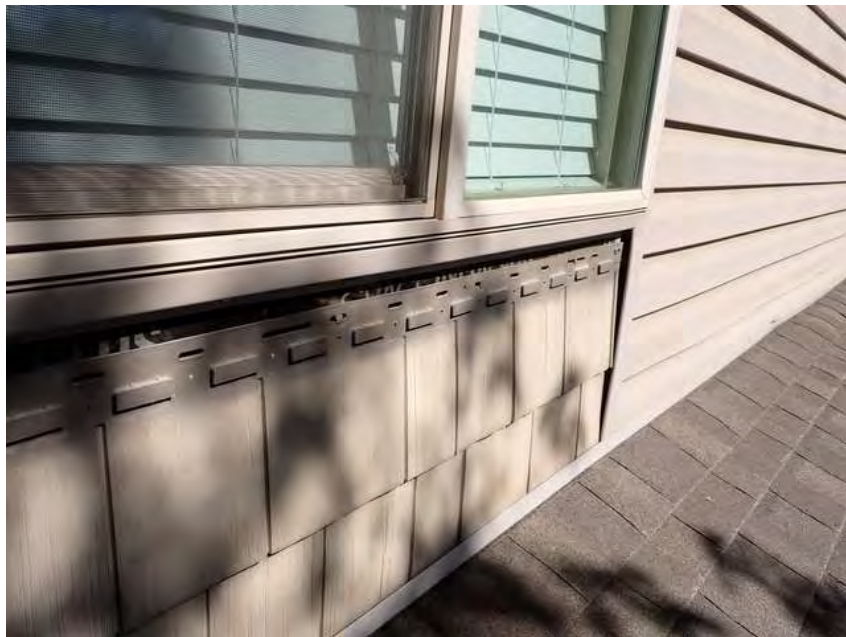
38. Building 2. Detail of missing trim.

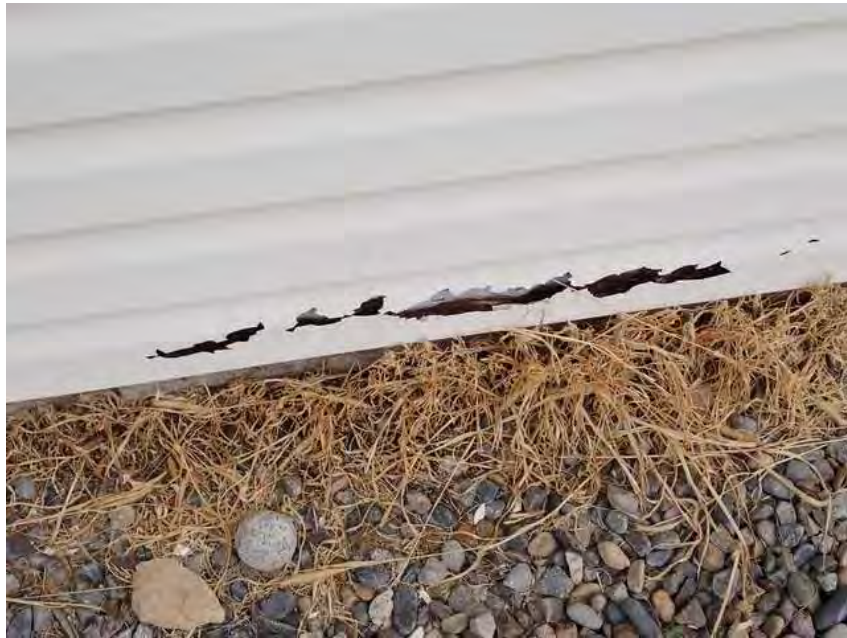
45. Building 3. Tear in vinyl siding. Likely mechanical damage from string trimmer.

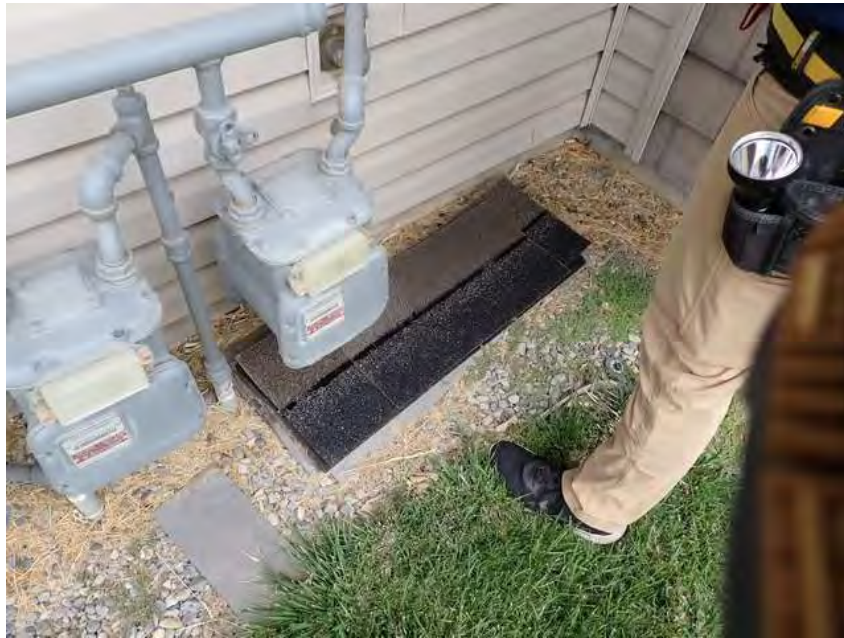
61. Building 4. Found shingles.

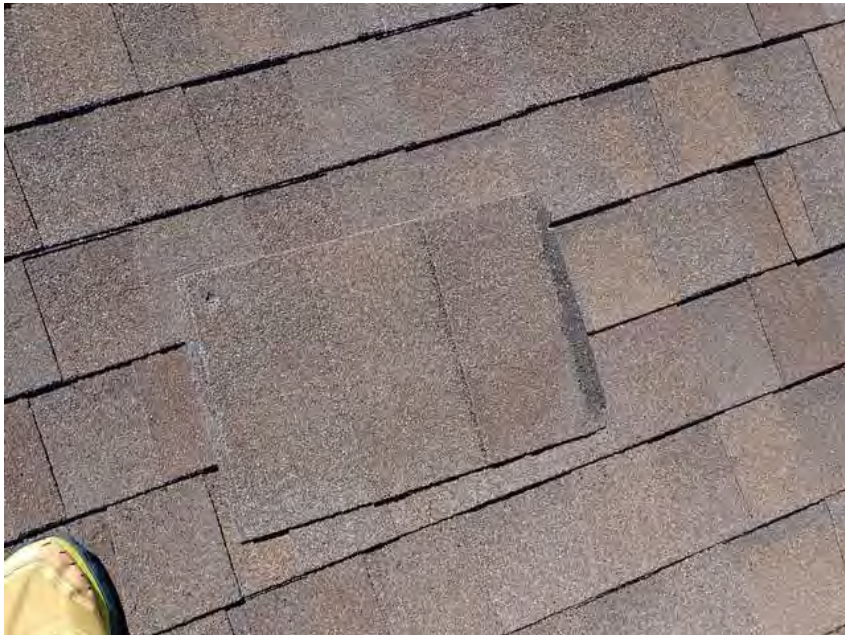
104. Building 6 Loose ridge cap shingle found on roof field.

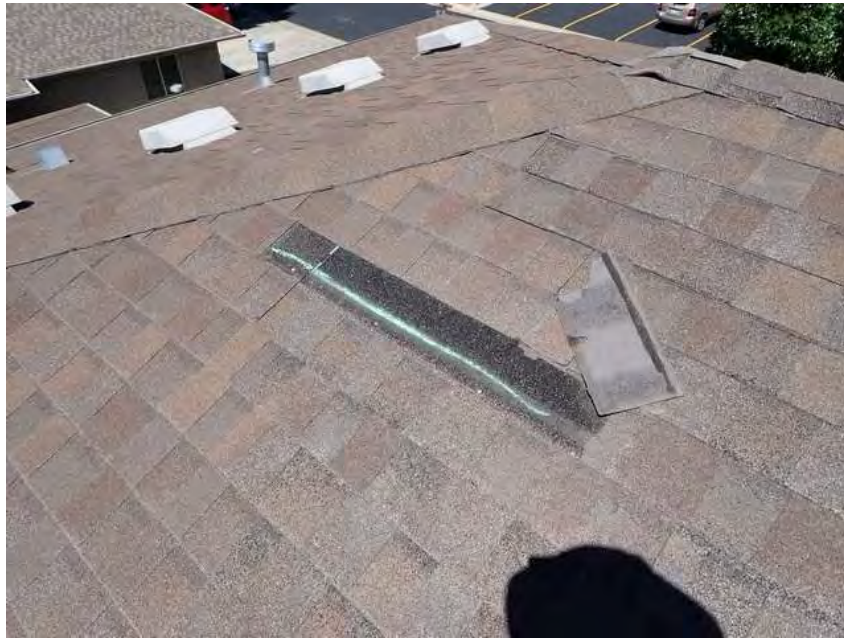
field shingles and approximately six linear feet of ridge cap shingles were found throughout the property. Damaged shingles above repairs were generally on the second course above the repairs. It is likely that the 17 field shingles and 6 feet of ridge cap shingles were damaged by winds, and some ultimately torn or displaced from the roofs. Damaged shingles were consistent with reports of strong winds on June 20, 2024.

109. Building 6 Missing shingle due to recent winds.

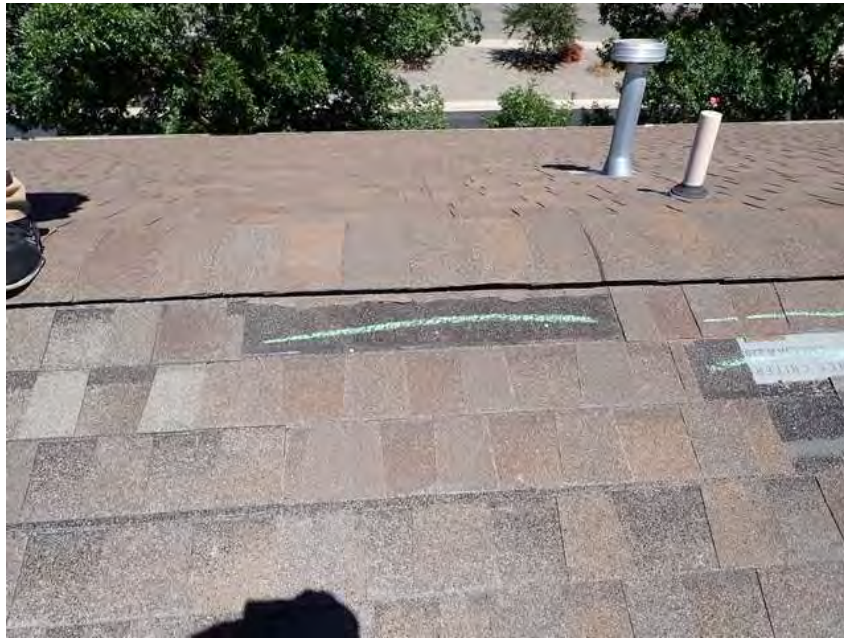
117. Building 6 missing shingle from recent winds.

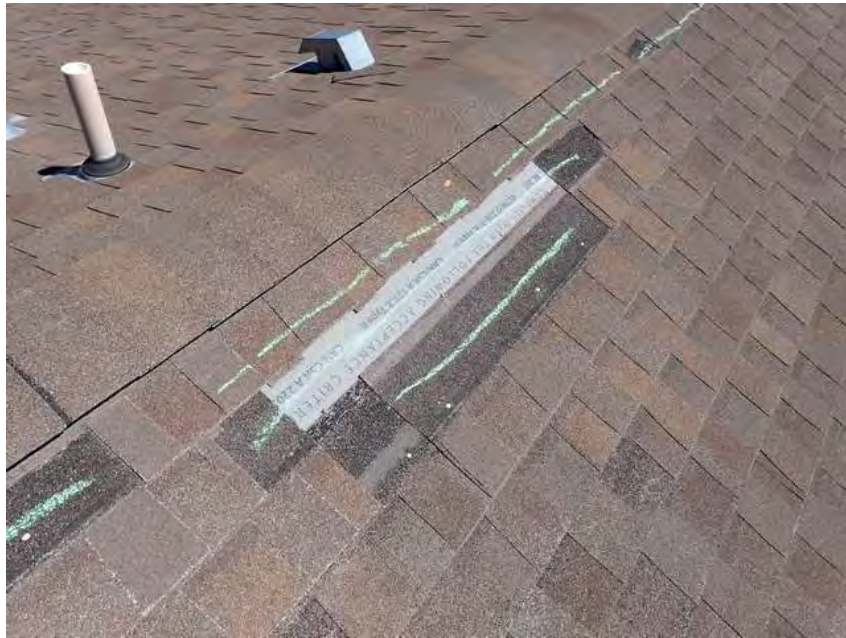
119. Building 6 Missing shingles from recent winds.

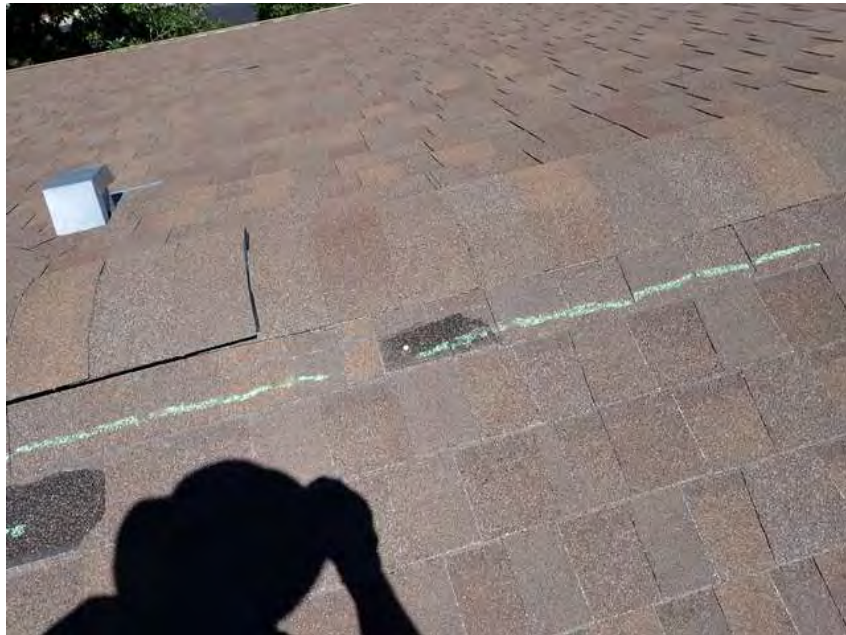
120. Building 6 Torn shingle.

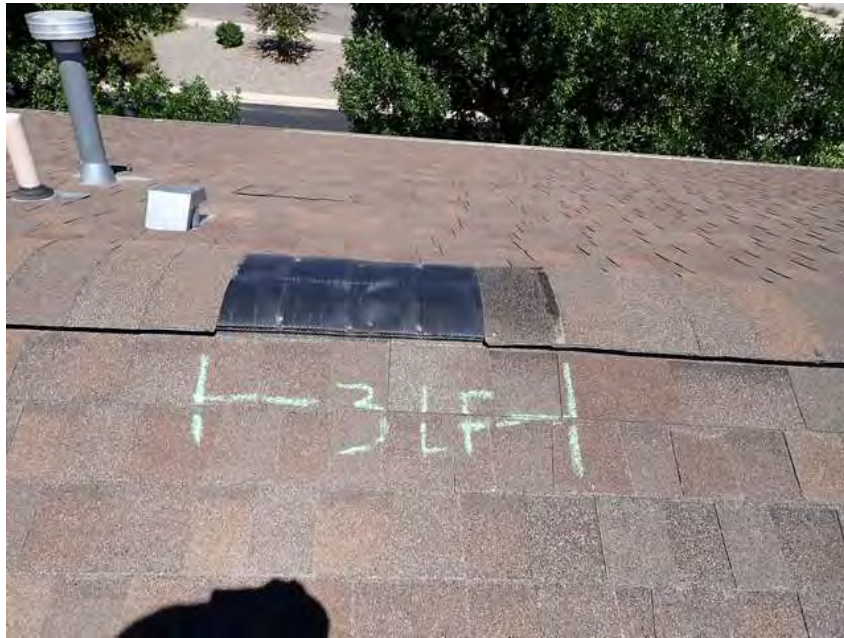
121. Building 6 Missing ridge cap.

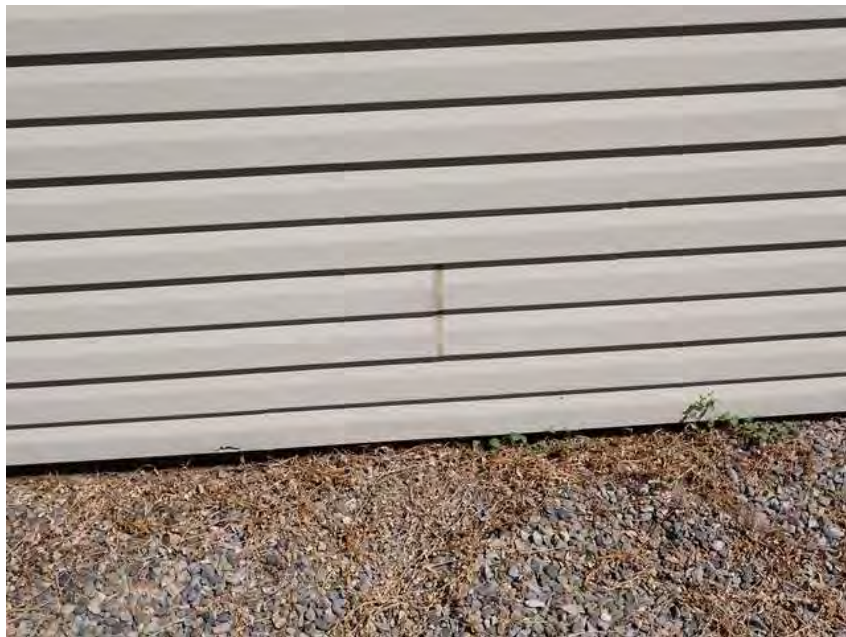
158. Building 9. Sealed gap in siding.

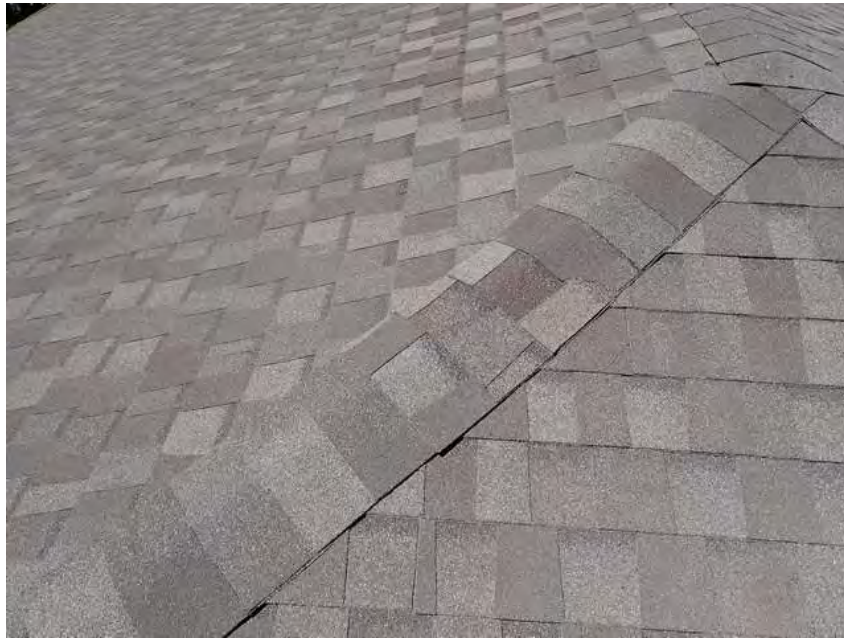
193. Building 11. Repair to ridge cap with cut shingles.

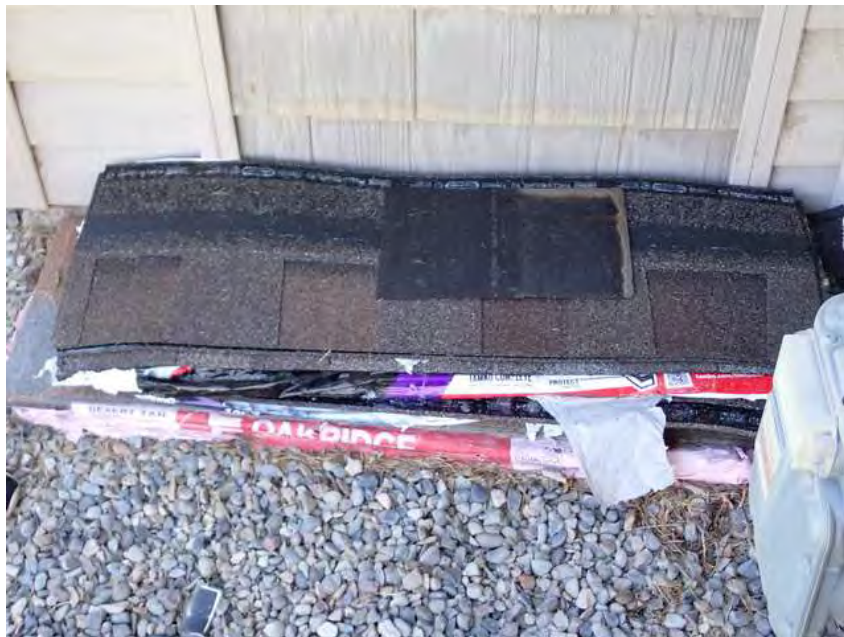
202. Building 12. Found shingles.

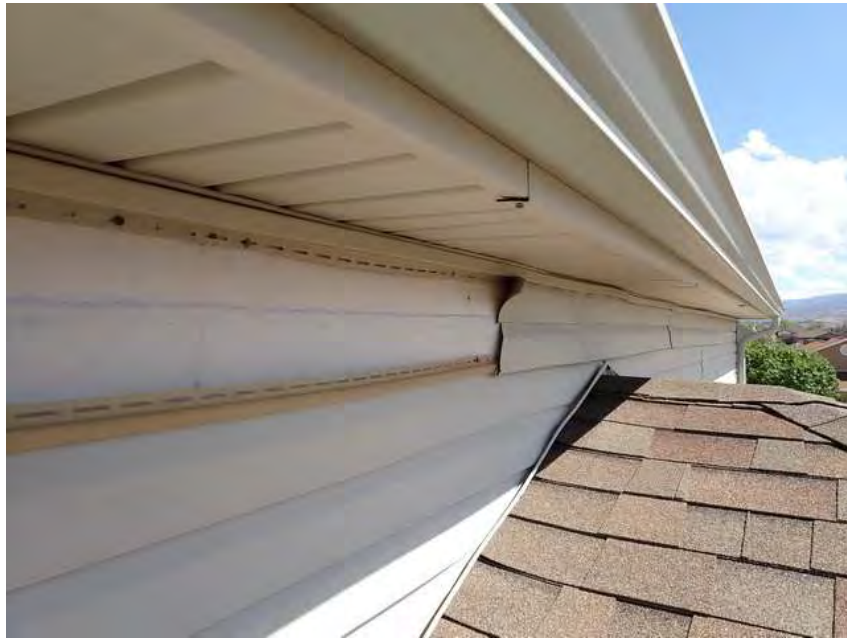
369. Building 22. Missing siding.

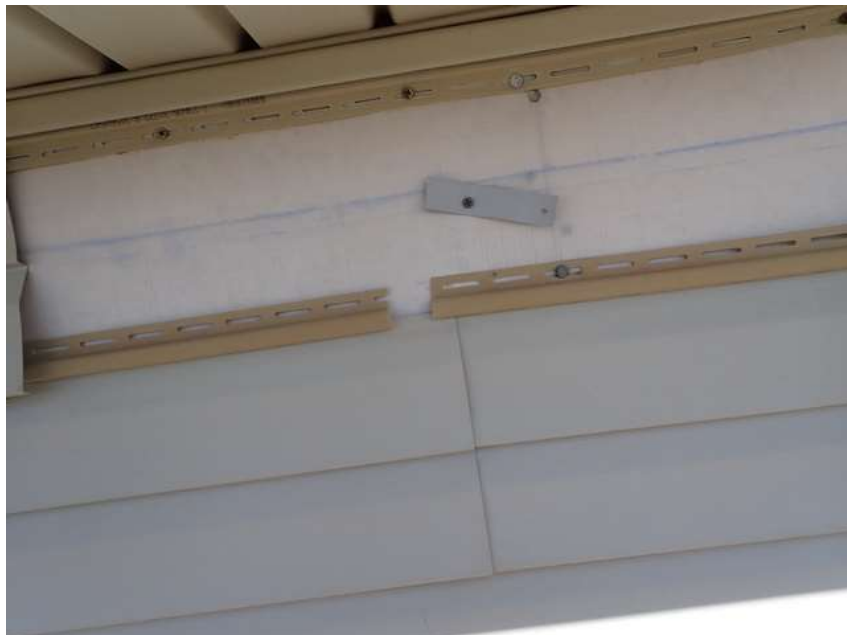
370. Building 22. Missing siding.

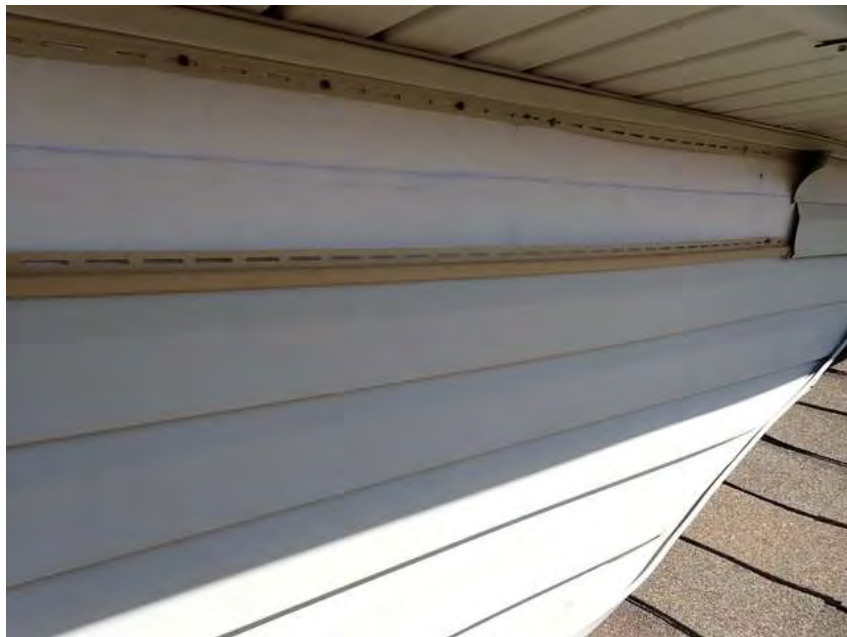
372. Building 22. Missing siding.

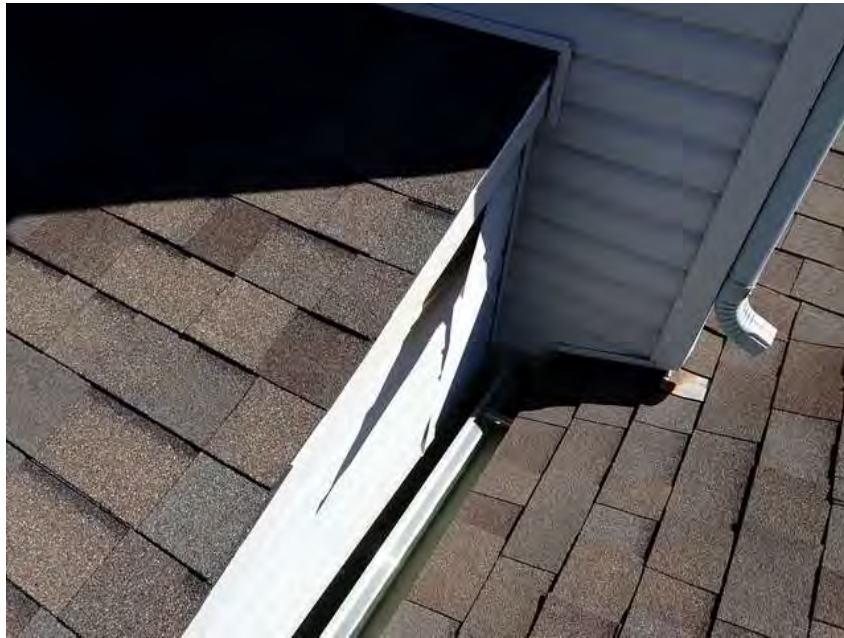
2. Exterior components and claddings at the property were generally secure and were not displaced by winds, except as documented in Table A. Vinyl siding was found sagging or slipped in several locations. These conditions were consistent with wind events occurring on June 20, 2024.

373. Building 22. Displaced siding.

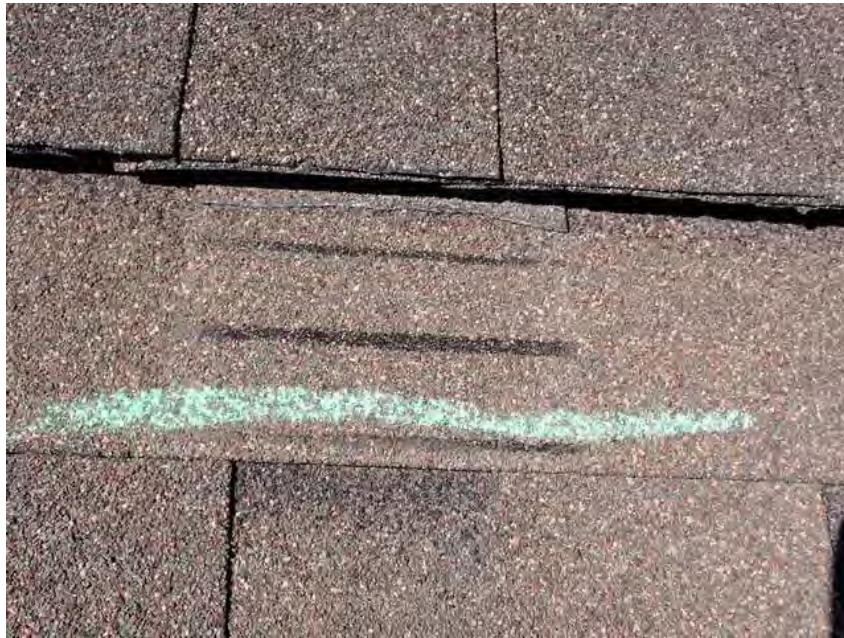
389. Building 22. Missing tooth on shingle.
