Brookwillow Village HOA
Building Elevation and Roof Evaluation
2450 1/2 Ajay Avenue
Grand Junction, CO 81505
Client File: 124830-1
Haag File: 12240428CO-1855/254

October 8, 2024

Re: Brookwillow Village HOA
Building Elevation and Roof Evaluation
2450 1/2 Ajay Avenue
Grand Junction, CO 81505
Client File: 124830-1
Haag File: 12240428CO-1855/254

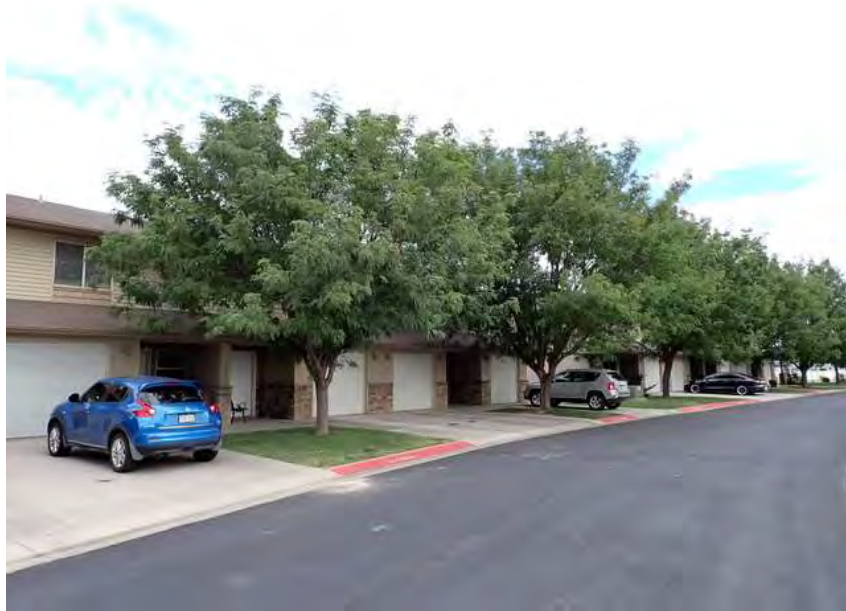
1. Building 1. Front overview.

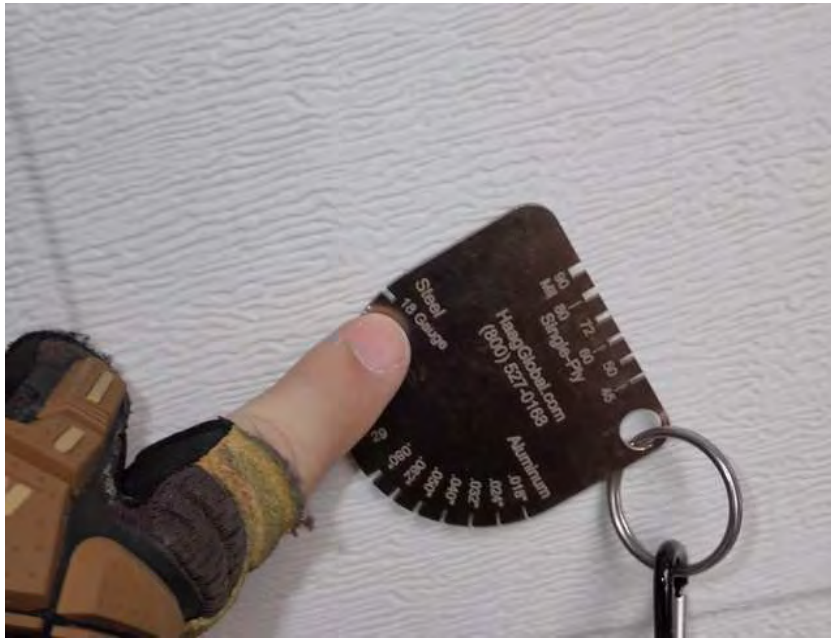
3. Building 1. Garage doors made from steel, typical throughout property.

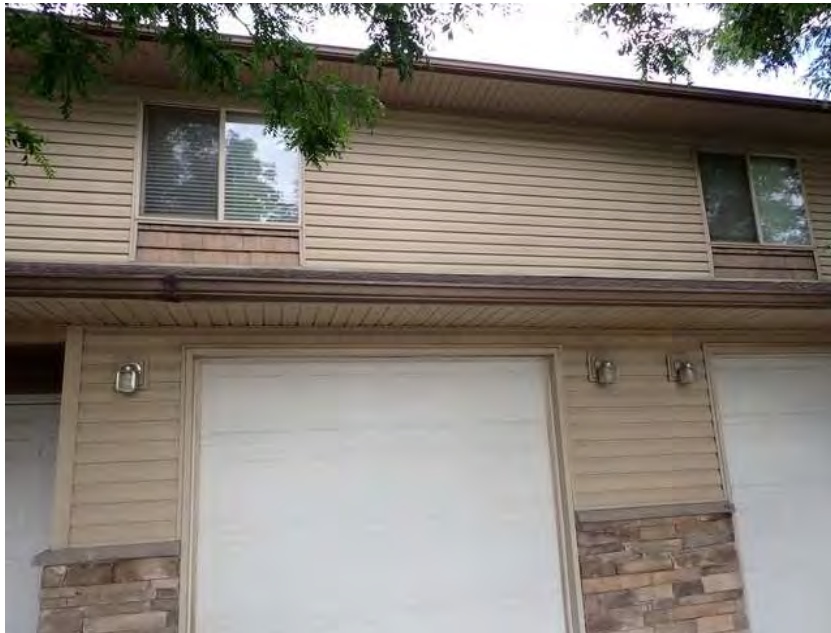
4. Building 1. Buildings 1-12 had a vinyl shake accent below windows.

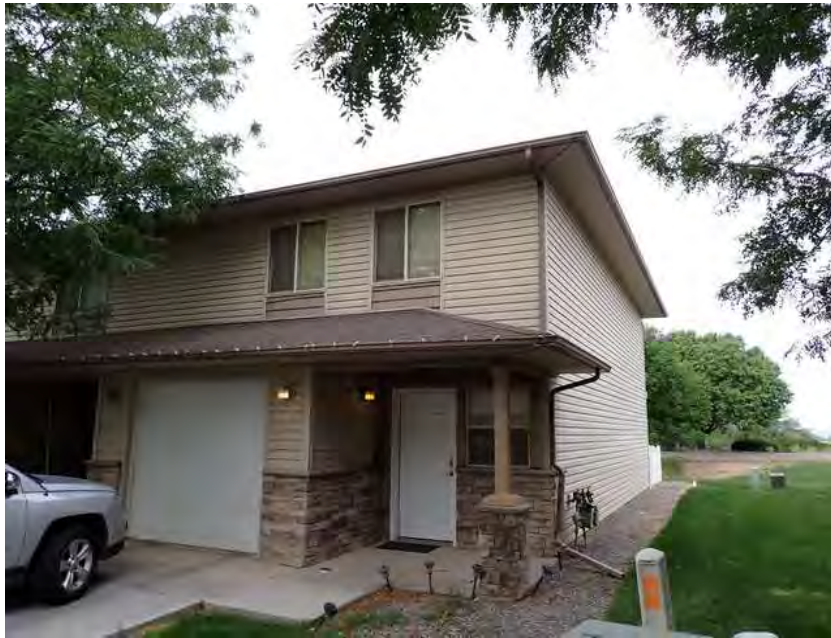
5. Building 1. Right overview.

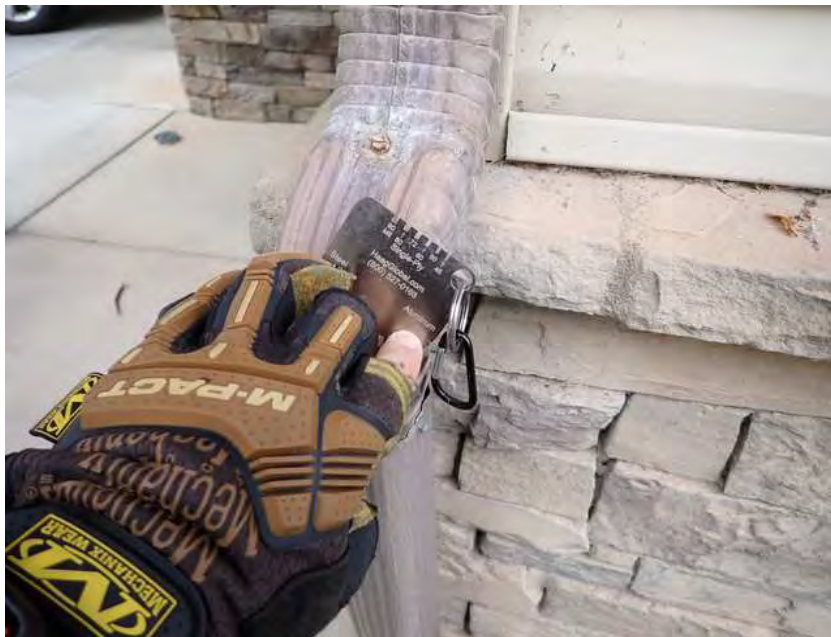
6. Building 1. Downspouts made from aluminum, typical throughout property.

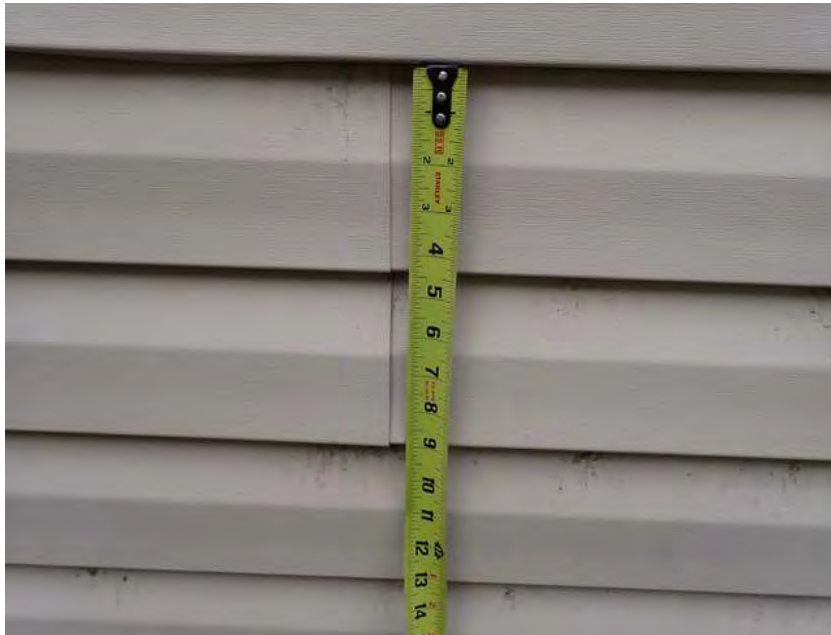
7. Building 1. Vinyl siding measured 9 inches tall.

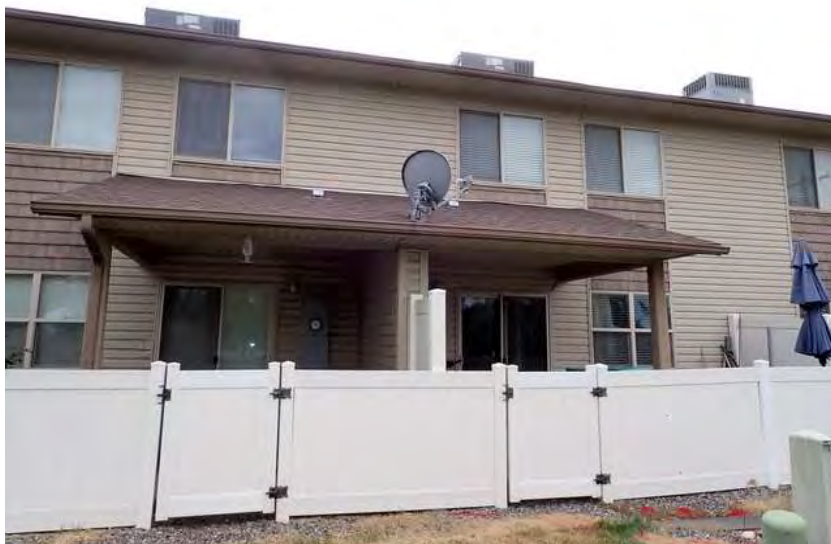
8. Building 1. Back overview.

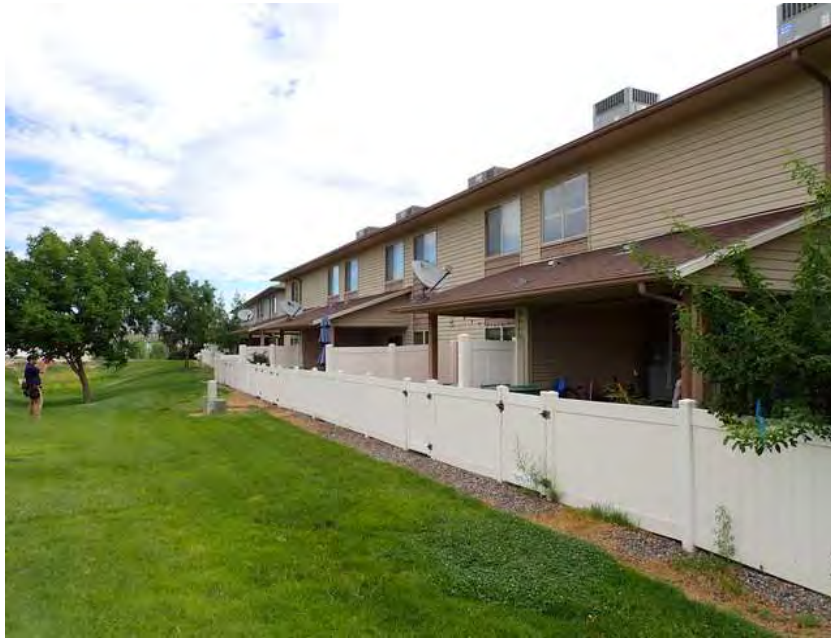
9. Building 1. Back overview.

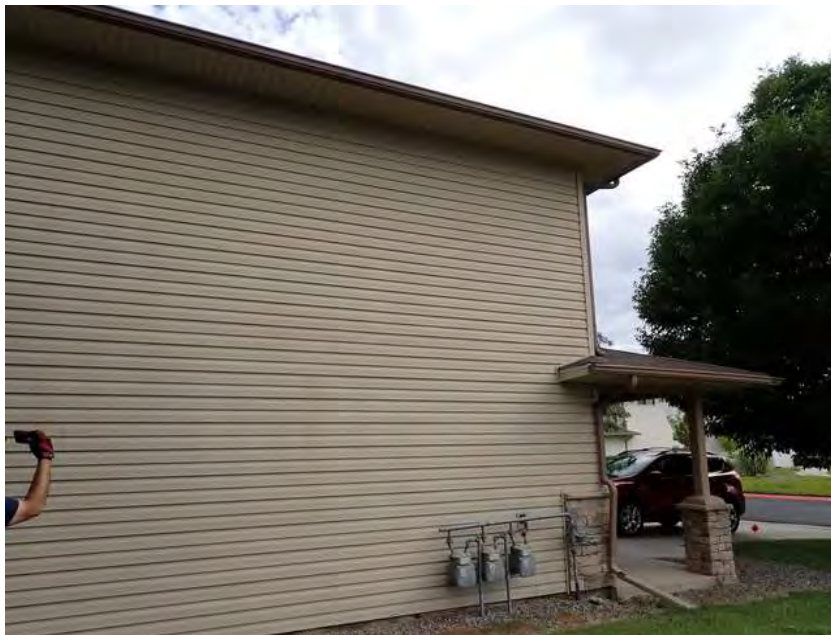
10. Building 1. Left overview.

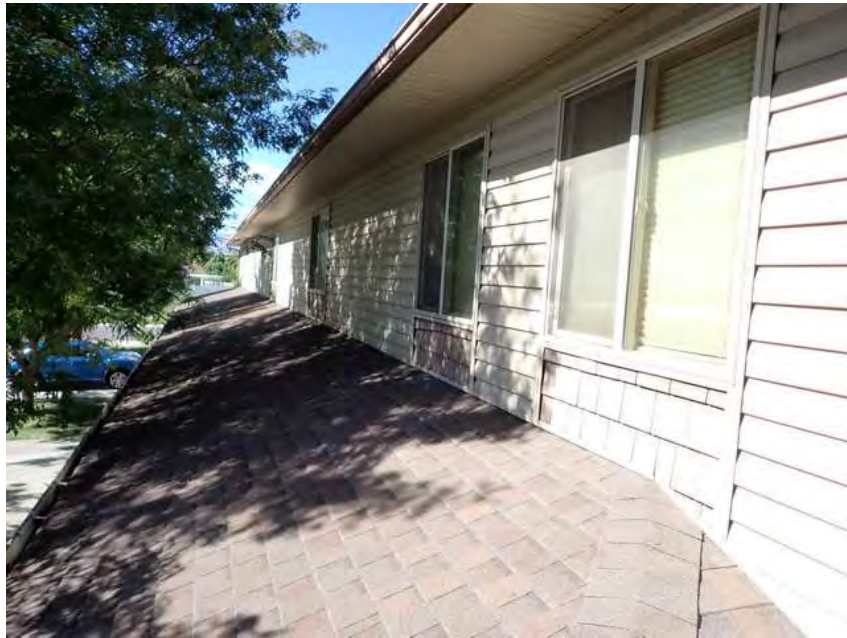
11. Building 1. Lower roof overview.

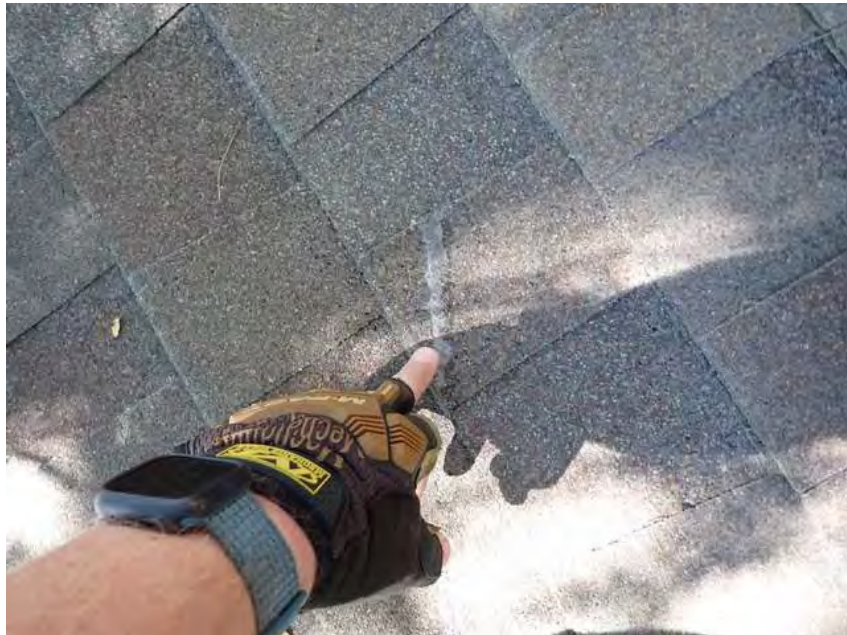
1. The shingles were in fair condition with respect to weathering. Scuffs and surface marring commonly found on asphalt shingles were distributed throughout the roof, but primarily located along ridges, easy access points, and near previous insert repairs. Insert repairs were located on many buildings, documented in Table A. We elevated shingles throughout the roofs to reasonably gain access to the fasteners. We were able to raise the bottom edges of shingles without creasing or tearing the shingles. The shingles were pliable and serviceable.

12. Building 1. Mar in granule coverage.

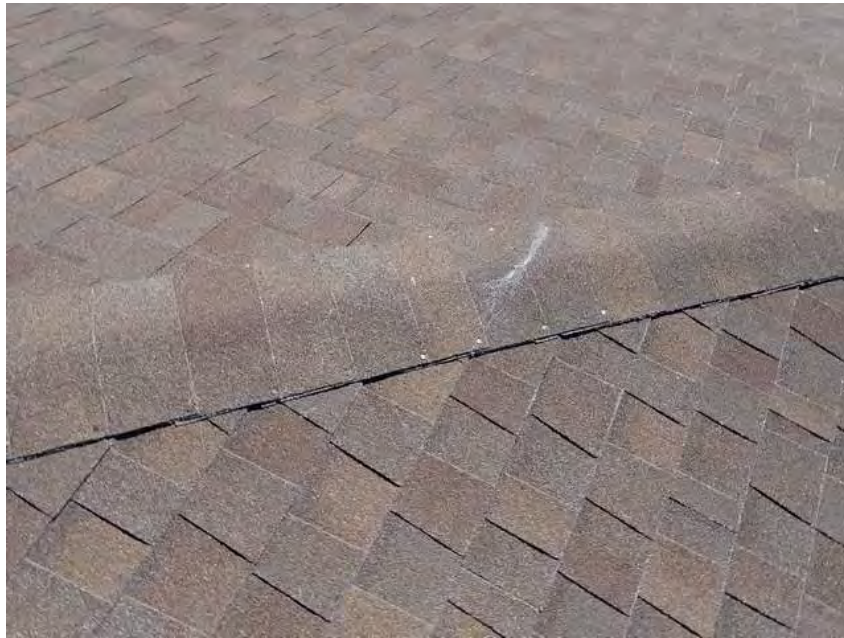
15. Building 1. Mechanical impact to ridge cap shingles.

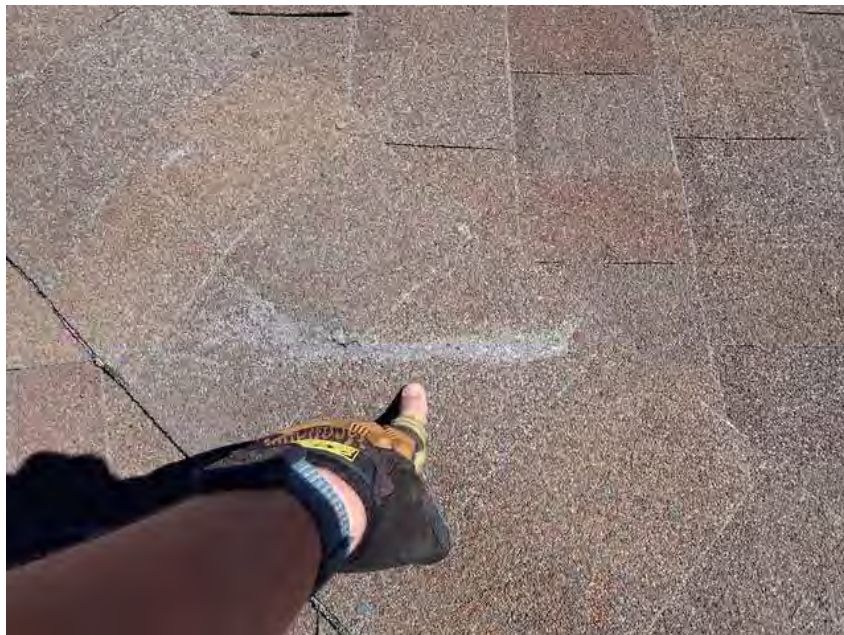
16. Building 1. Detail of mechanical impact.

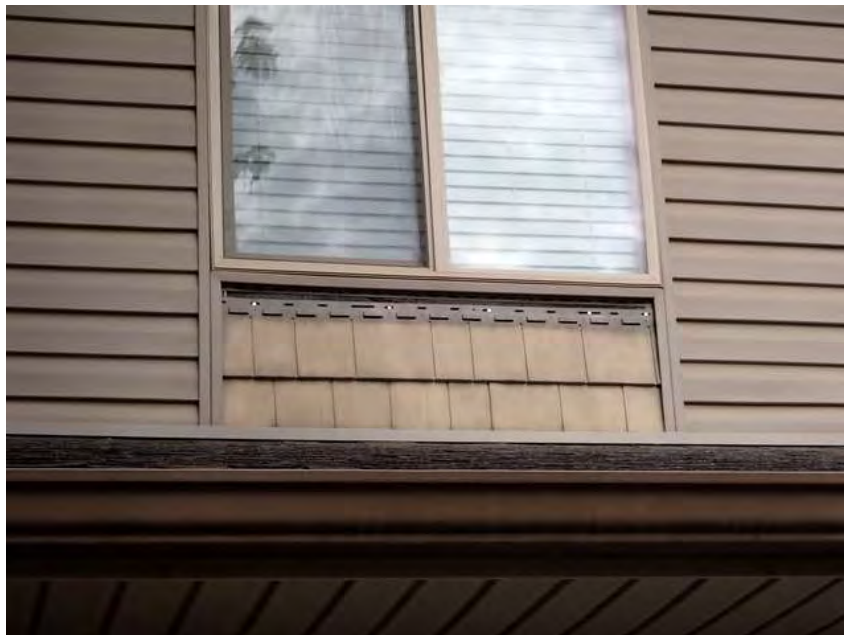
30. Building 2. Missing trim over vinyl shakes.

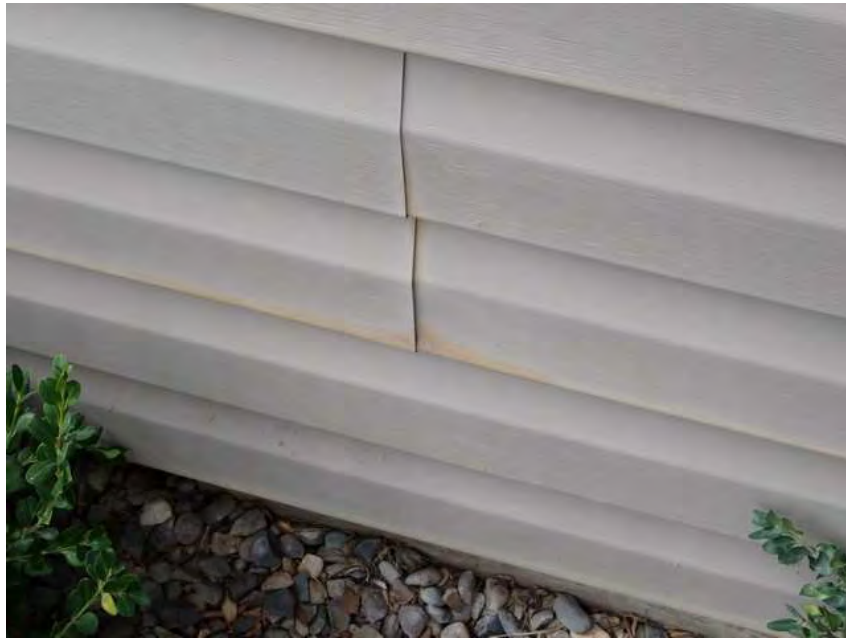
33. Building 2. Discoloration on vinyl siding.

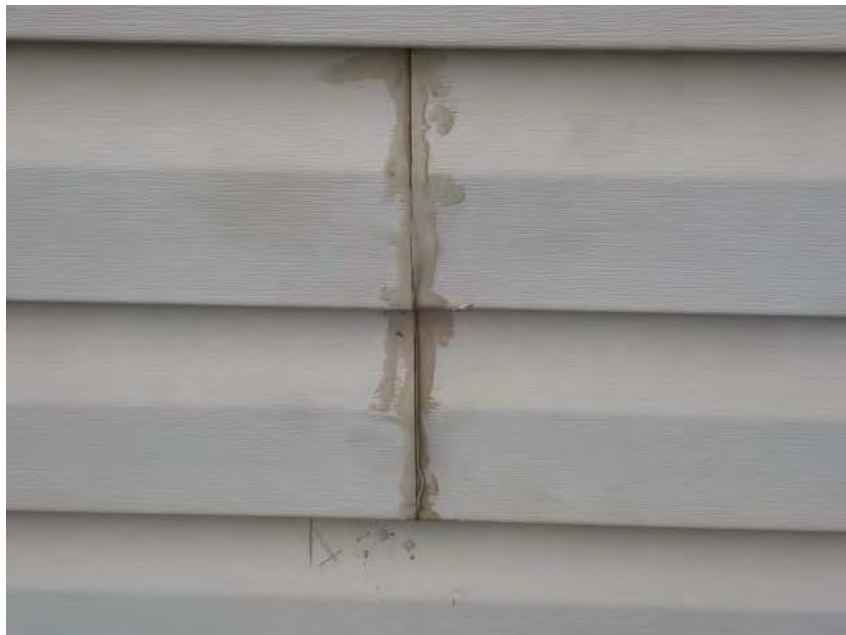
34. Building 2. Patched gap in siding.

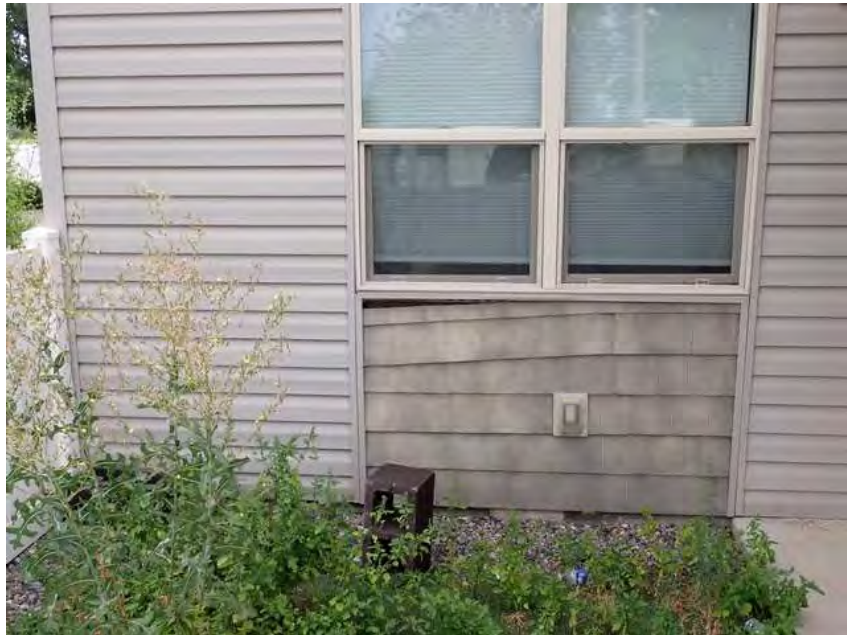
2. Exterior components and claddings at the property were generally secure and were not displaced by winds, except as documented in Table A. Vinyl siding was found sagging or slipped in several locations. These conditions were consistent with wind events occurring on June 20, 2024.

36. Building 2. Sagged vinyl shakes.

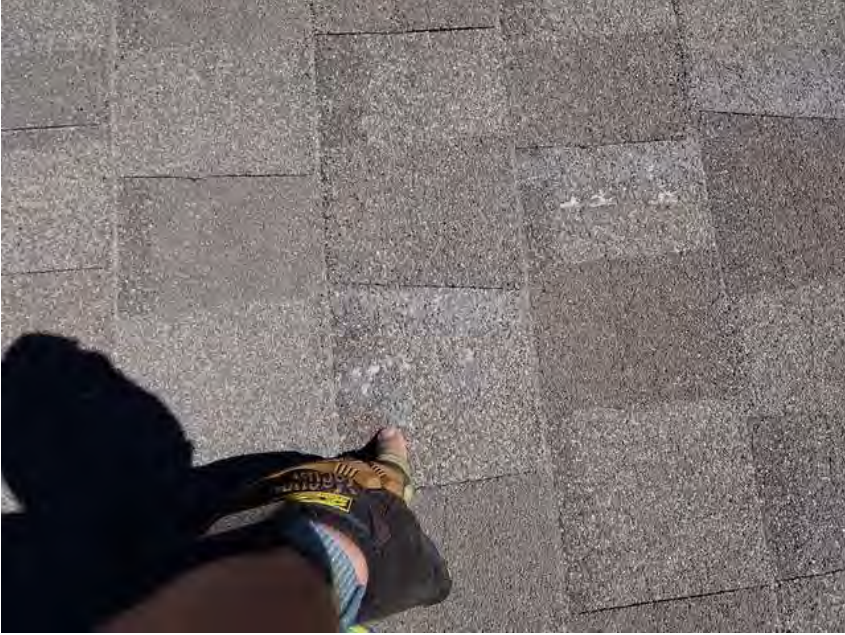
41. Building 2. Granule loss.

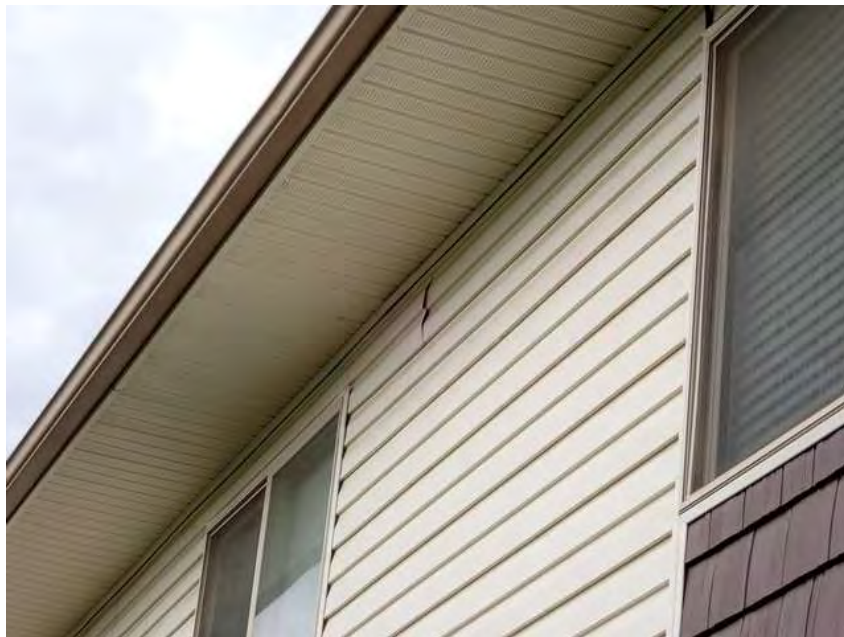
48. Building 3. Gap in siding.

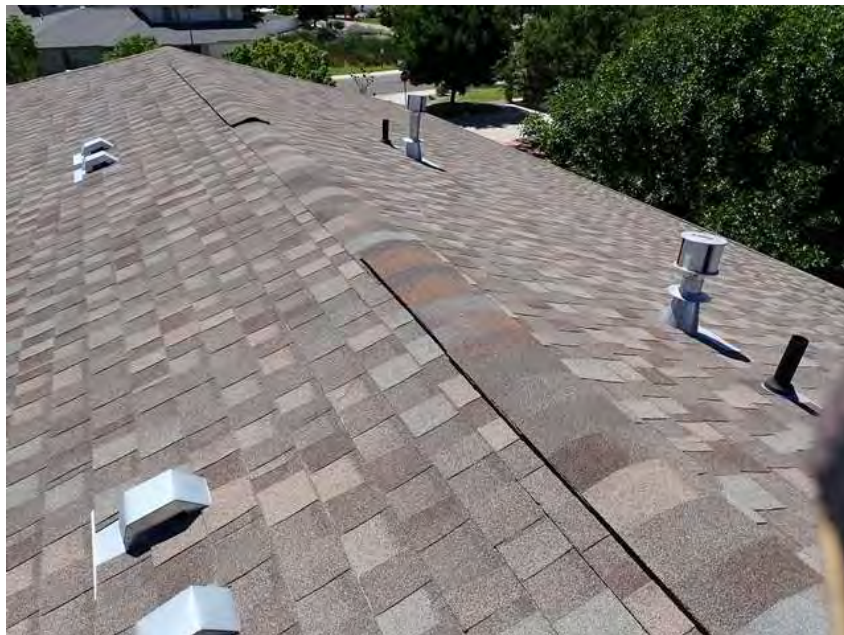
54. Building 3. Possible mismatch on ridge cap shingles.

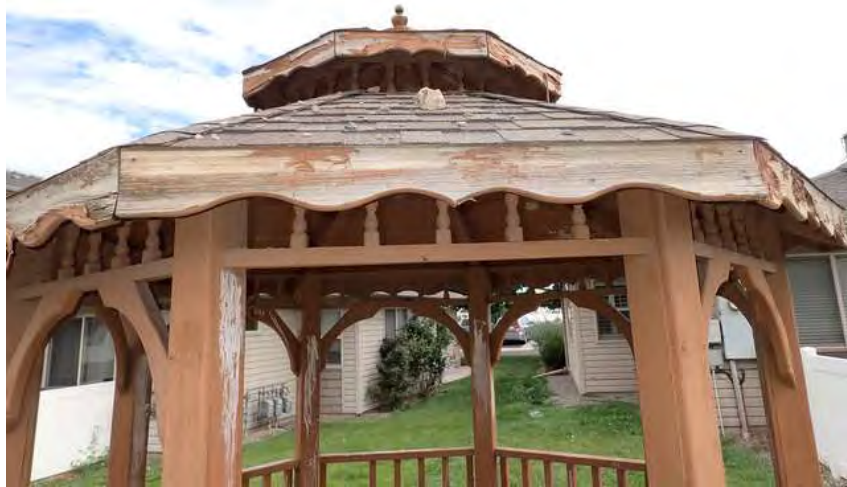
73. Building 4. Gazebo 1 had asphalt shingles. Rocks have been thrown on the roof of gazebo 1.

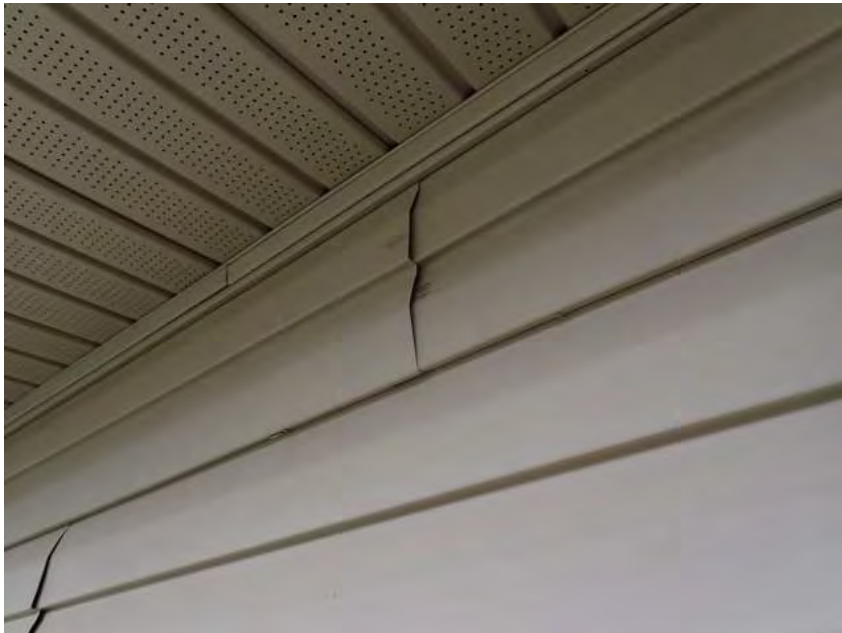
76. Building 5. Gap in siding likely due to installation issues.

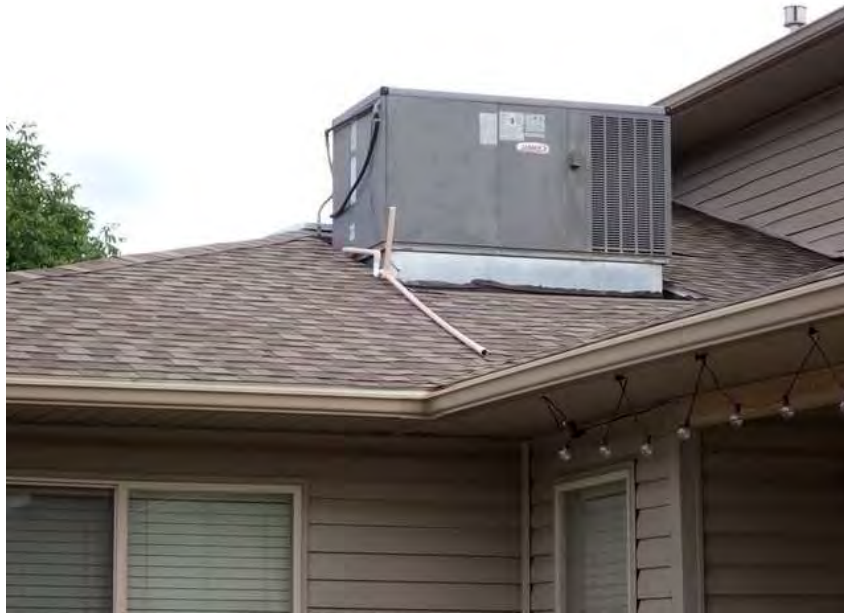
77. Building 5. PVC drainage pipe from AC unit not secured to roof.

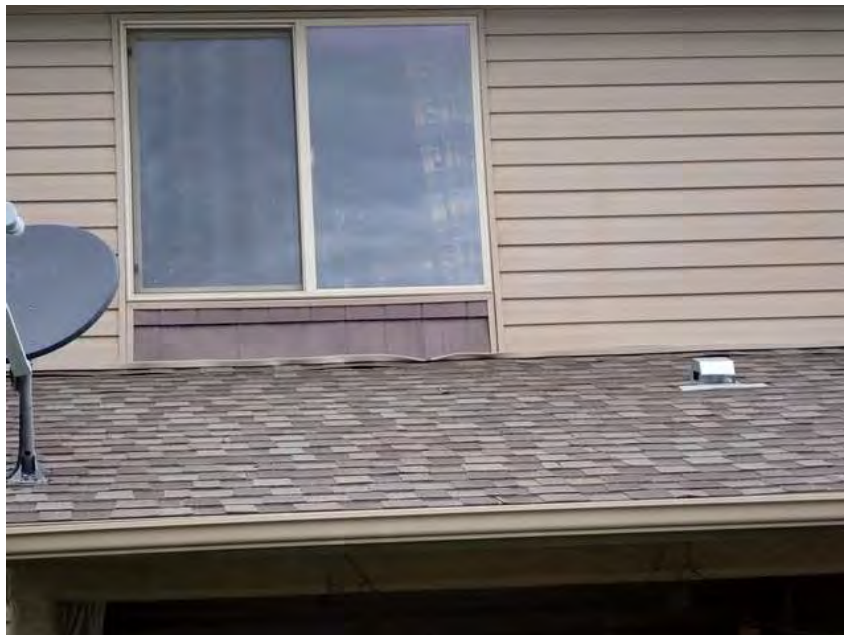
78. Building 5. Deformation of trim.

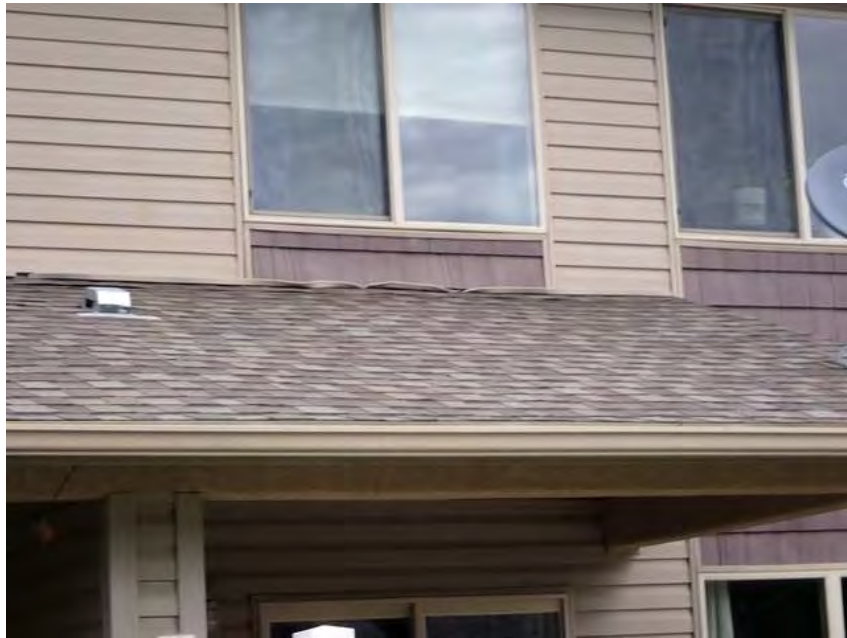
79. Building 5. Deformation of trim.

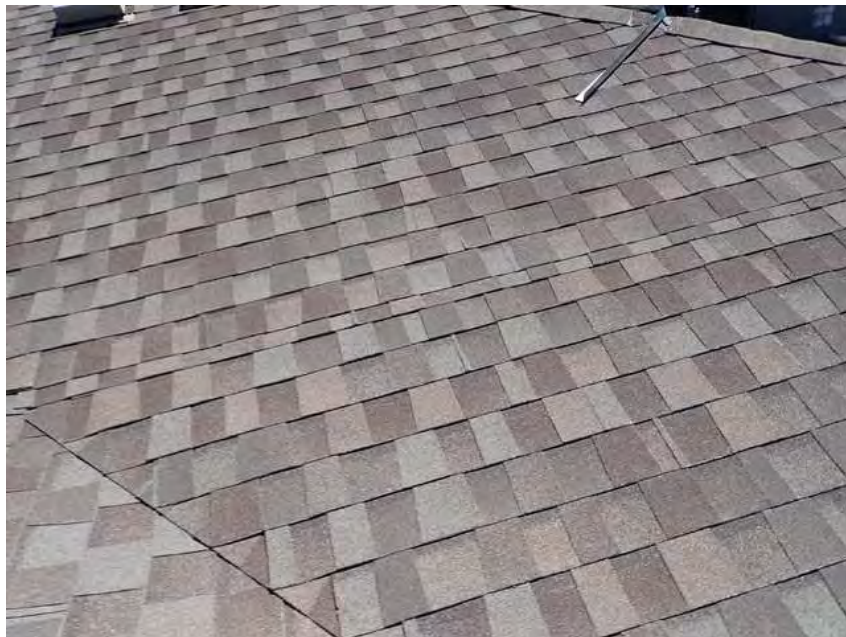
84. Building 5. Shingle misalignment.

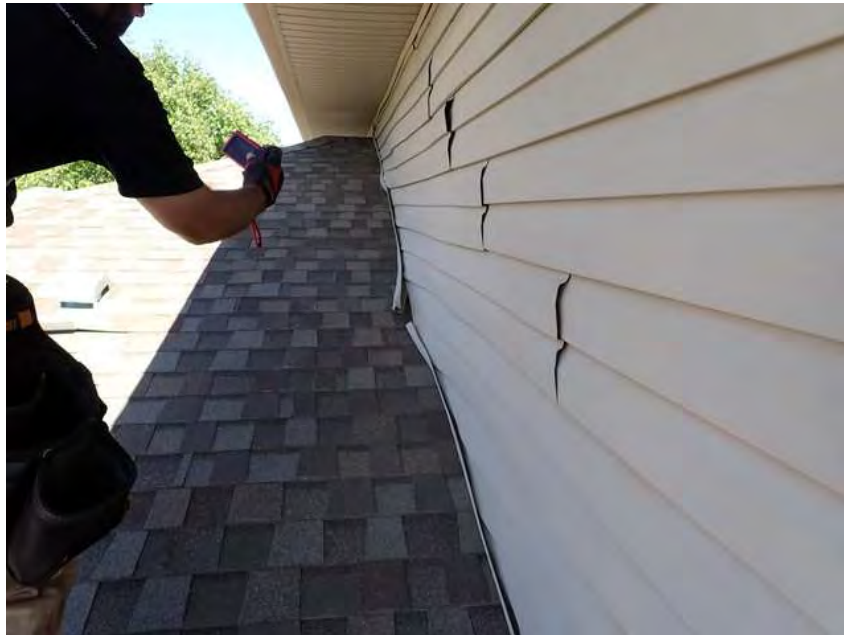
85. Building 5. Gaps in siding.

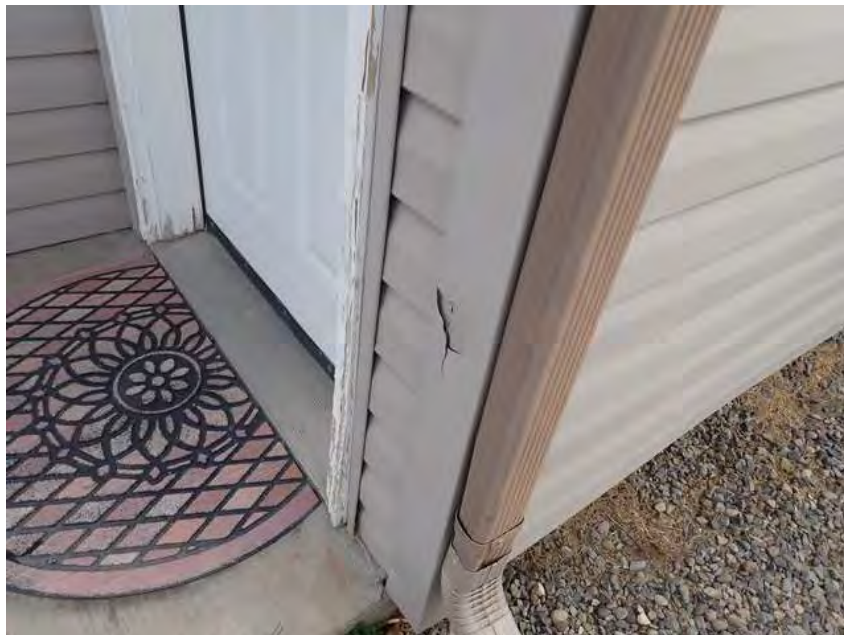
94. Building 6 Fractured siding.

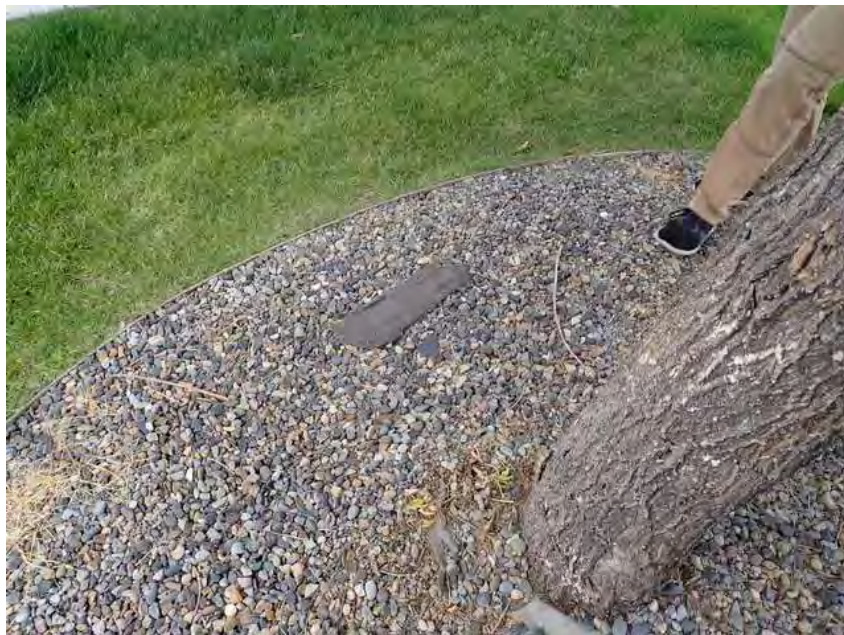
96. Building 6 Found portion of shingle on ground.

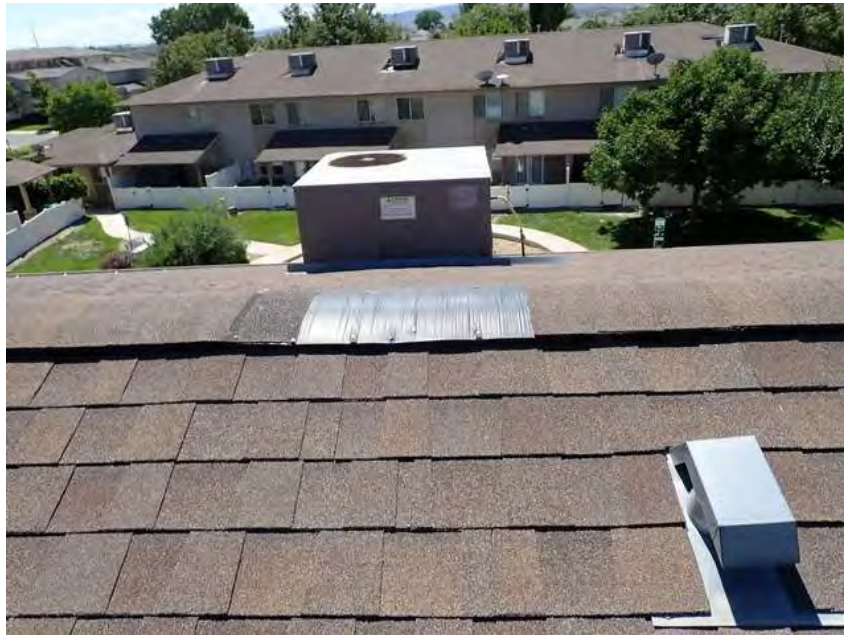
105. Building 6 Missing shingles from ridge cap.

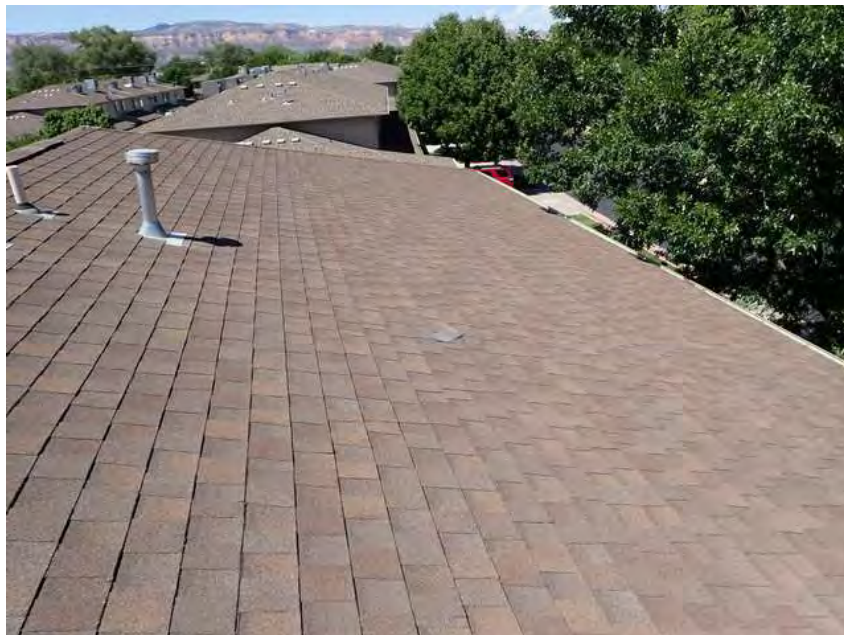
106. Building 6 Loose shingle fragment.

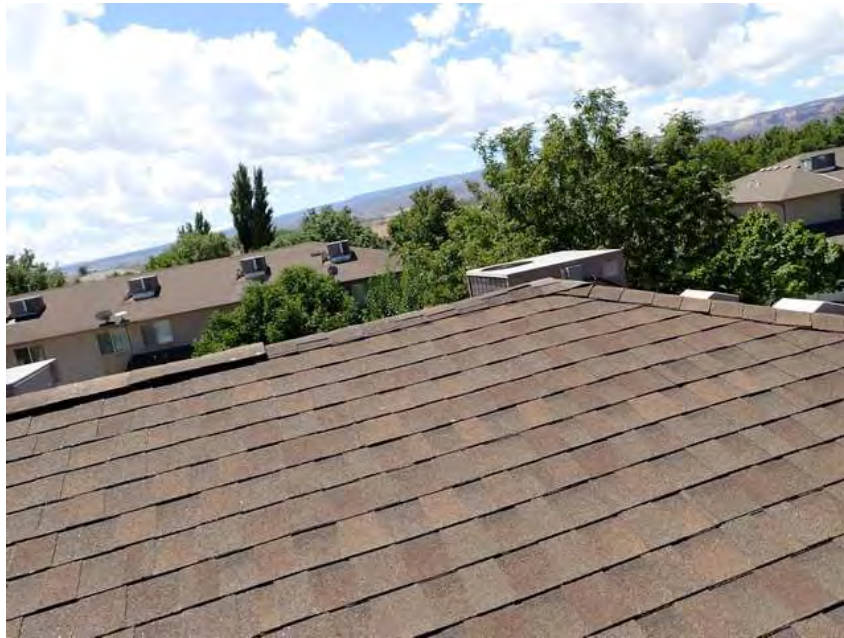
107. Building 6 Repair to ridge with cut shingles.

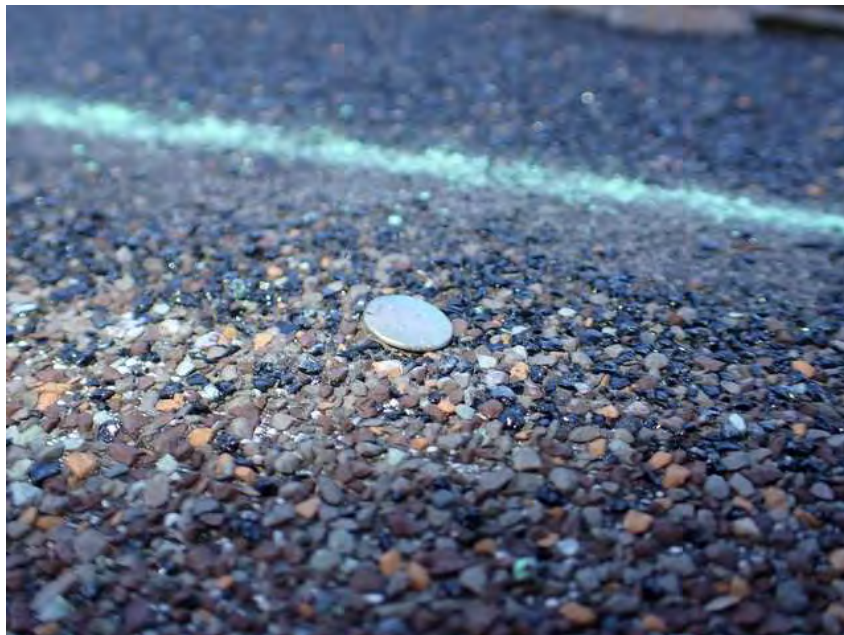
112. Building 6 Fasteners appear correctly installed.

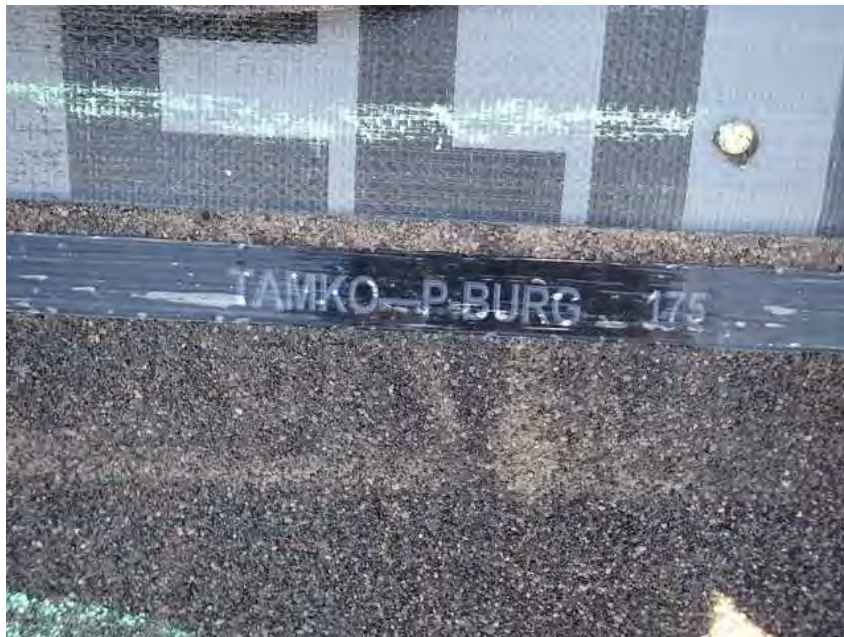
114. Building 6 Shingles on this building made by Tamko.

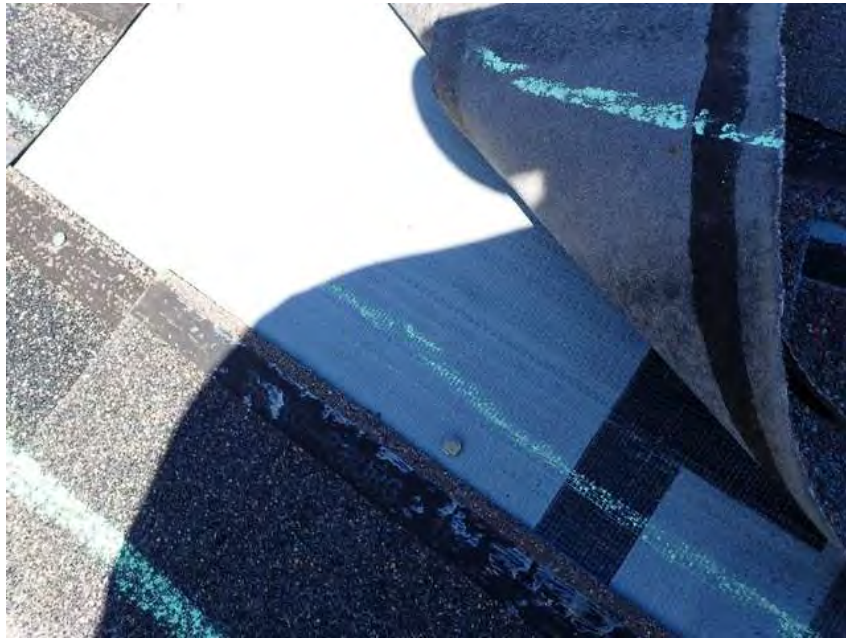
115. Building 6 Roof barrier exposed.

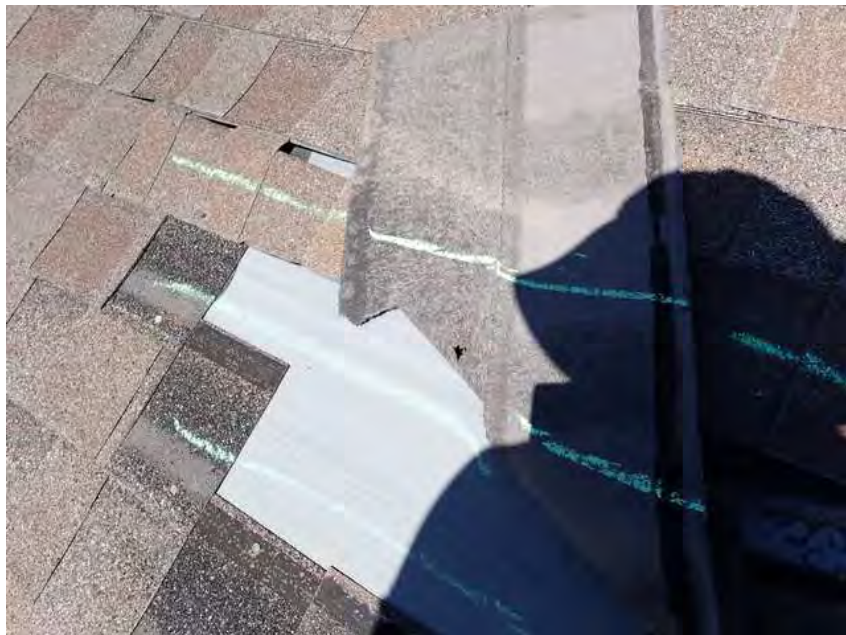
116. Building 6 Adjacent shingles appear to have slipped.

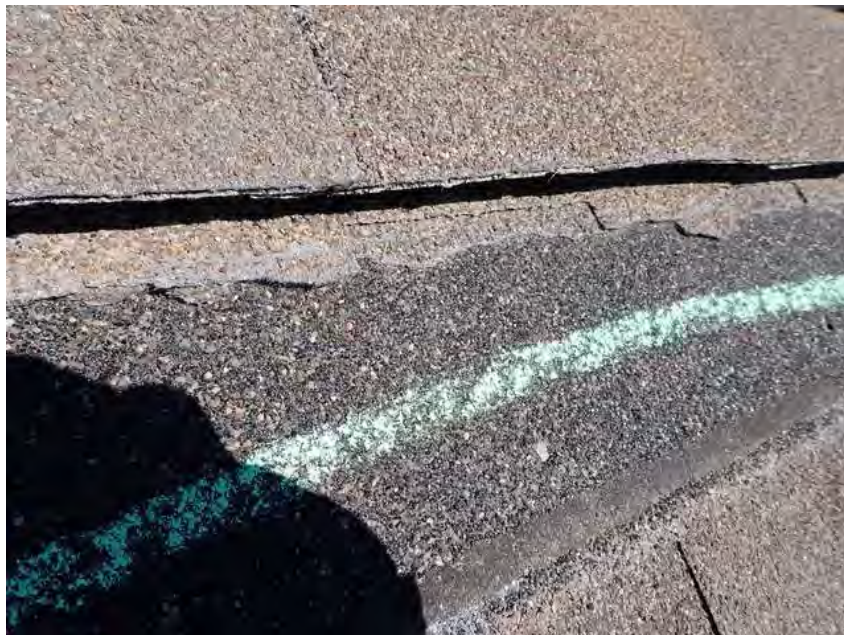
118. Building 6 Appears gray fibers at rip, suggesting an older crease resulting ultimately in a tear.

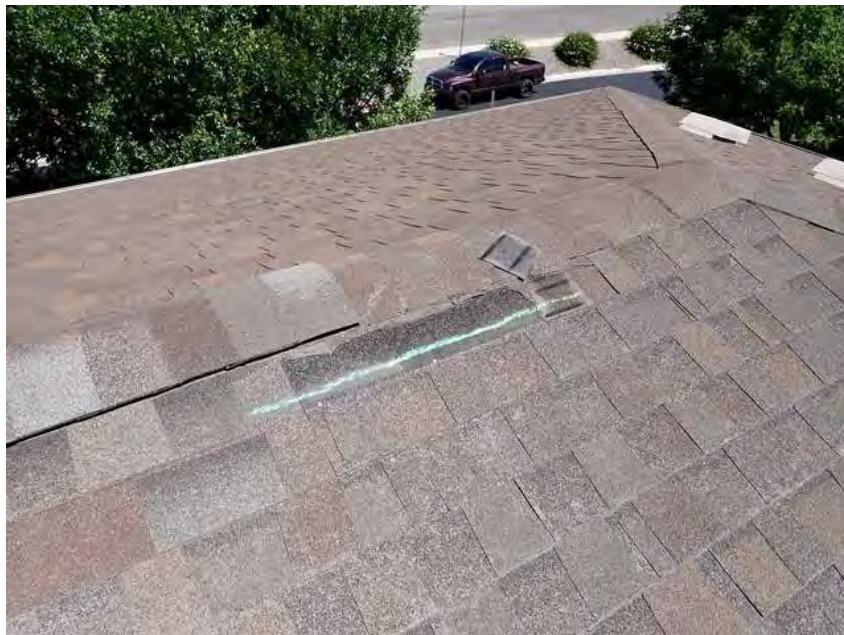
122. Building 6 Missing shingle.

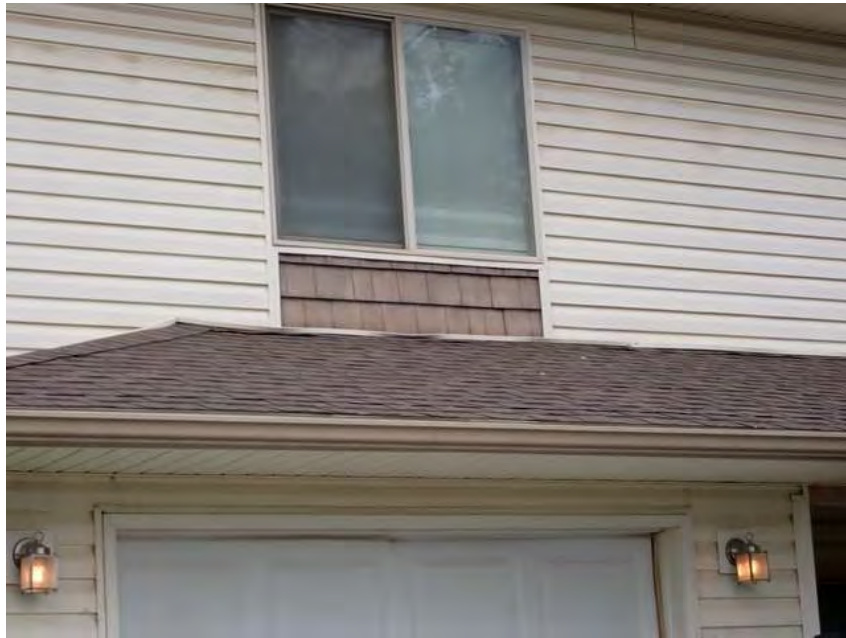
125. Building 7. Deformation in trim.

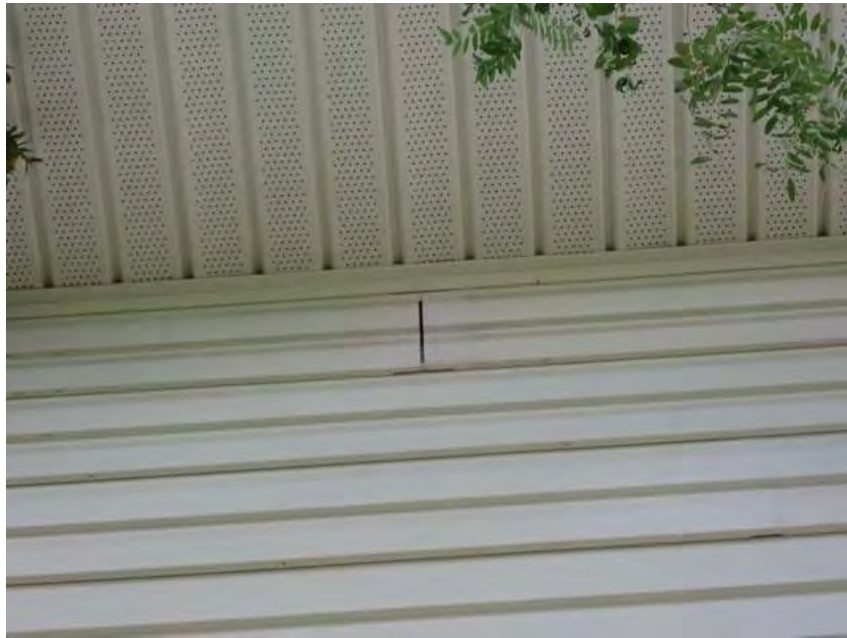
127. Building 7. Gap in siding.

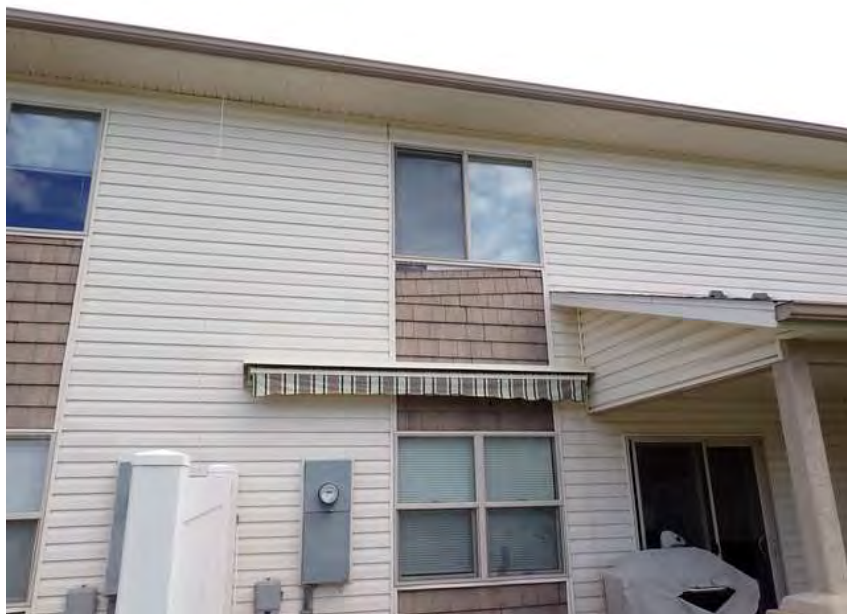
128. Building 7. Sagged vinyl shakes.

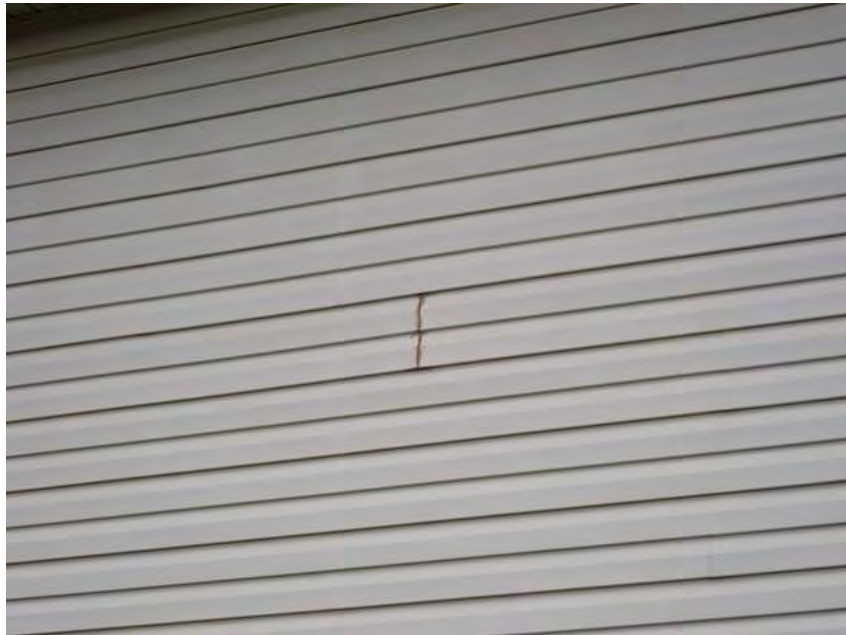
130. Building 7. Sealed gap in siding.
