Brookwillow Village HOA
Building Elevation and Roof Evaluation
2450 1/2 Ajay Avenue
Grand Junction, CO 81505
Client File: 124830-1
Haag File: 12240428CO-1855/254

October 8, 2024

Re: Brookwillow Village HOA
Building Elevation and Roof Evaluation
2450 1/2 Ajay Avenue
Grand Junction, CO 81505
Client File: 124830-1
Haag File: 12240428CO-1855/254

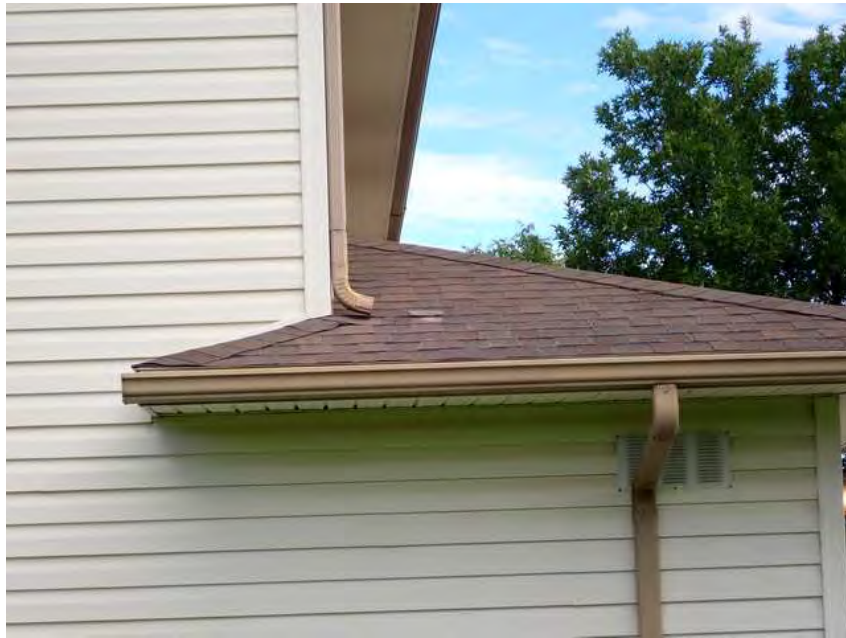
131. Building 7. Shingle tooth flipped back, possible due to downspout proximity.

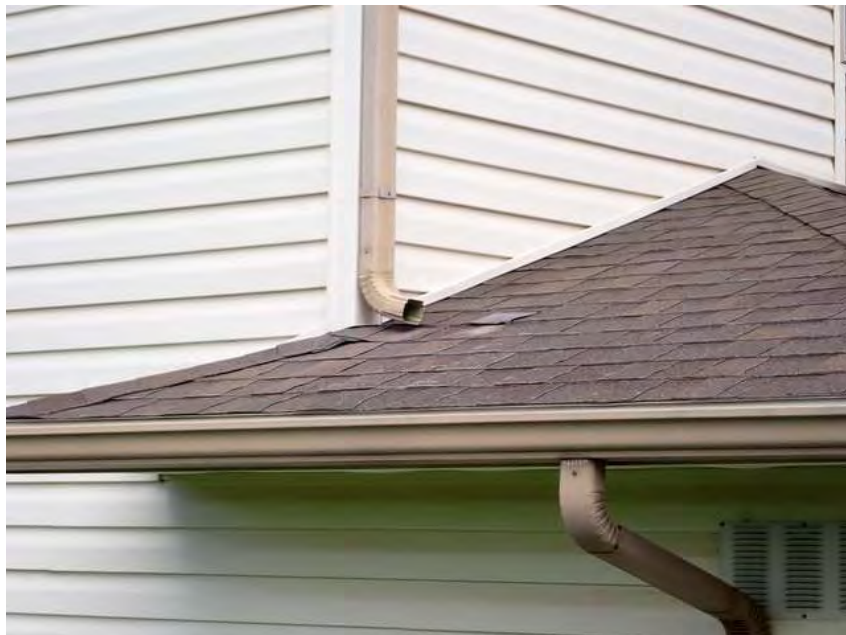
132. Building 7. Shingle tooth flipped back, possible due to downspout proximity.

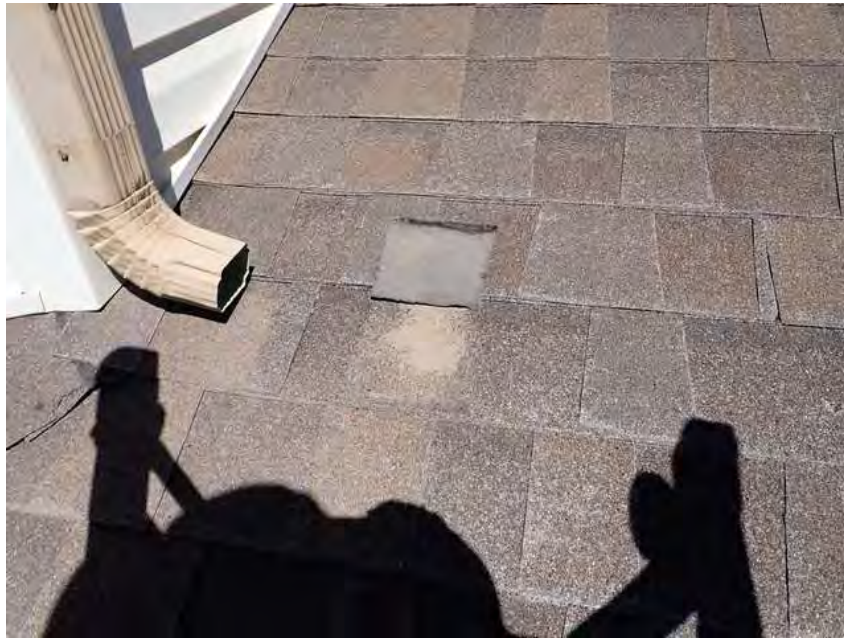
133. Building 7. Shingle tooth flipped back, possible due to downspout proximity.

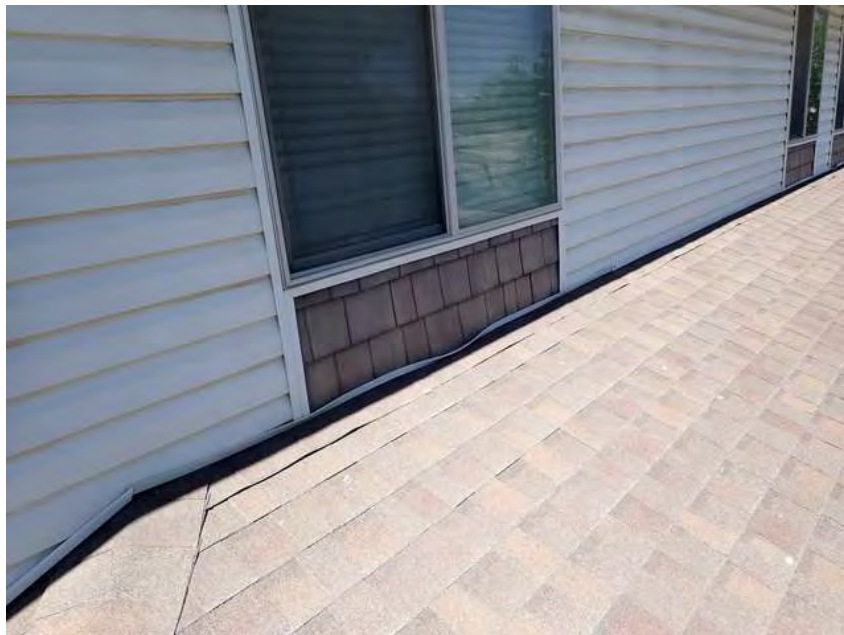
134. Building 7. Deformation in trim.

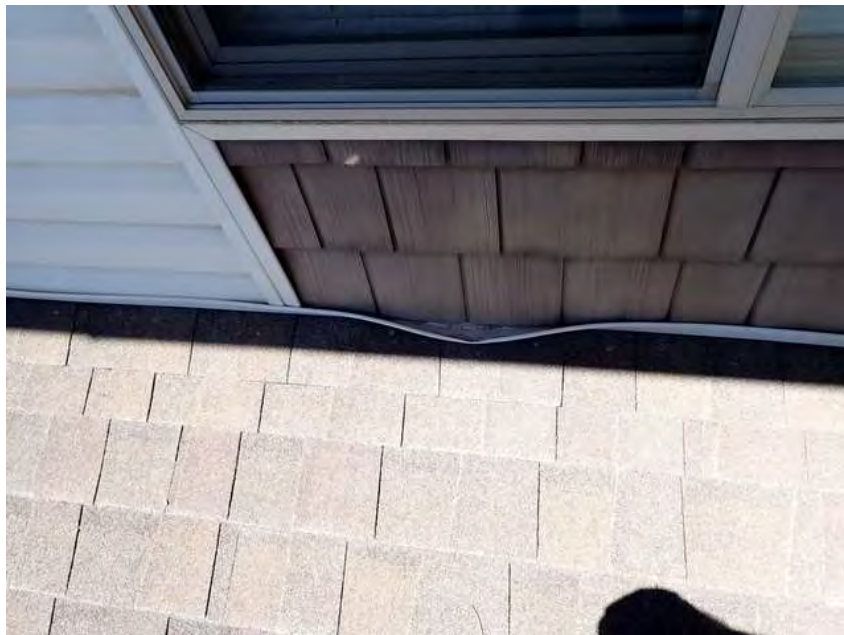
136. Building 7. Deformation in trim.

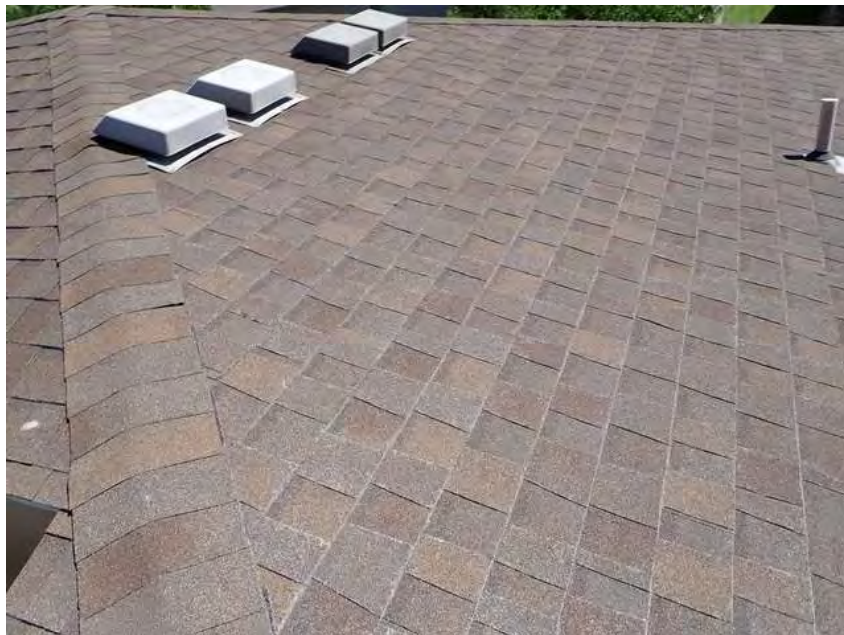
138. Building 7. Weathering on shingles.

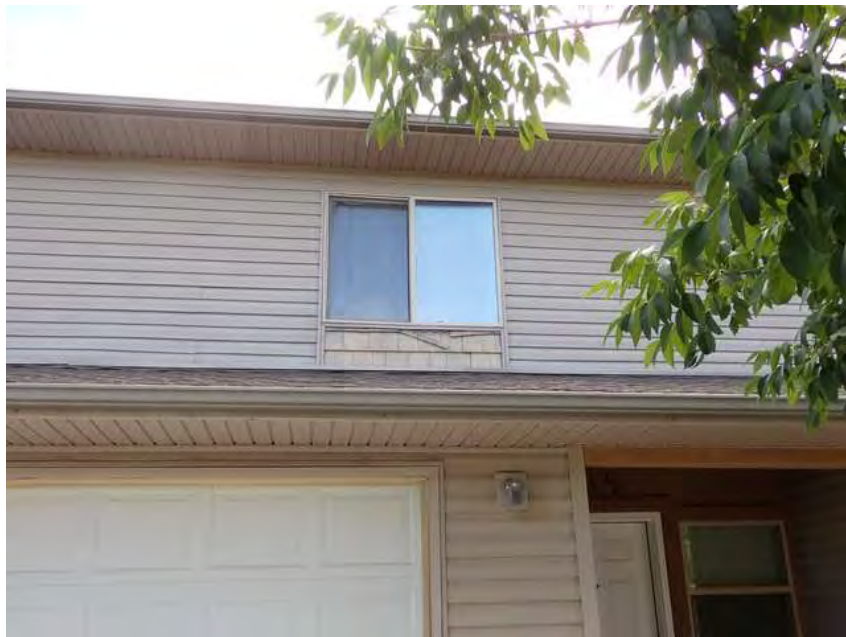
2. Exterior components and claddings at the property were generally secure and were not displaced by winds, except as documented in Table A. Vinyl siding was found sagging or slipped in several locations. These conditions were consistent with wind events occurring on June 20, 2024.

142. Building 8. Sagged vinyl shakes.

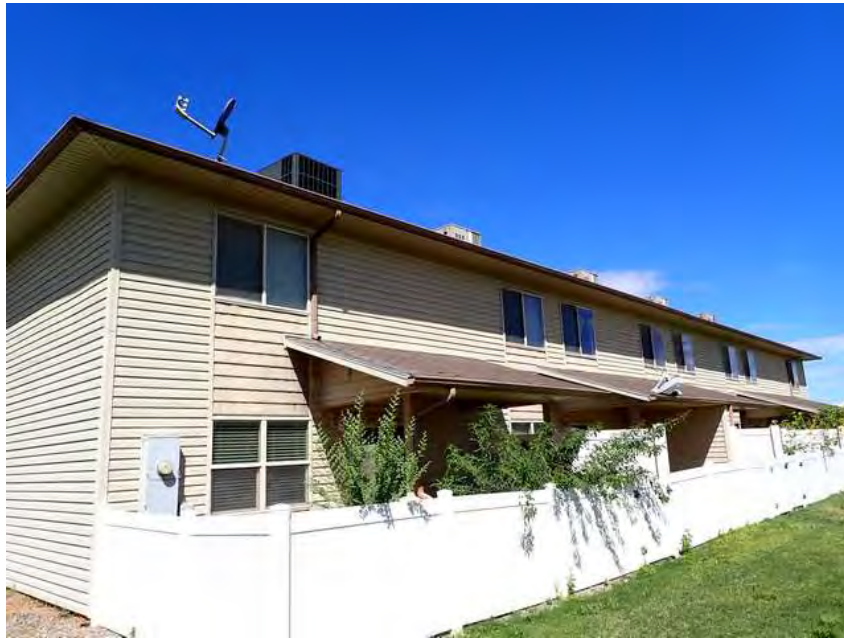
158. Building 9. Sealed gap in siding.

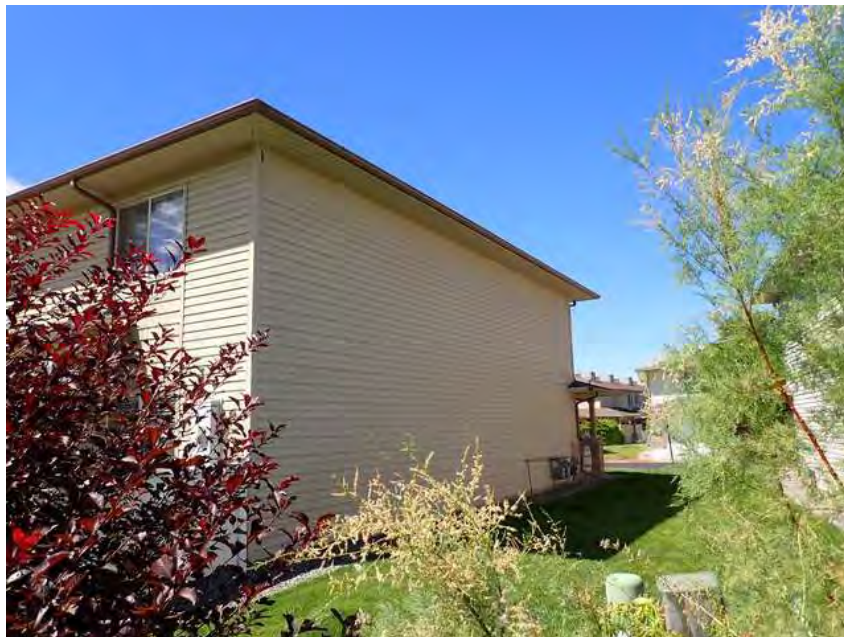
161. Building 9. Sagged vinyl shakes.

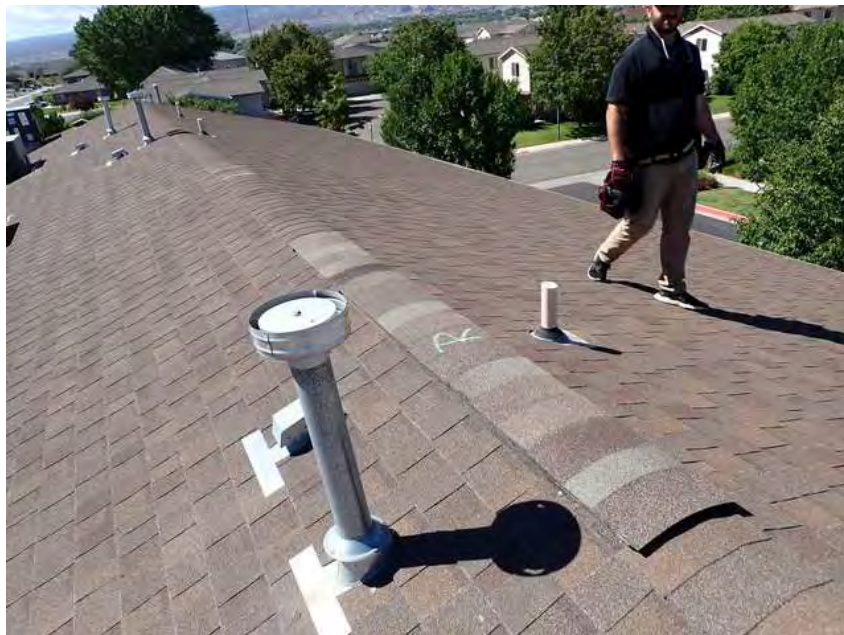
165. Building 9. Repair.

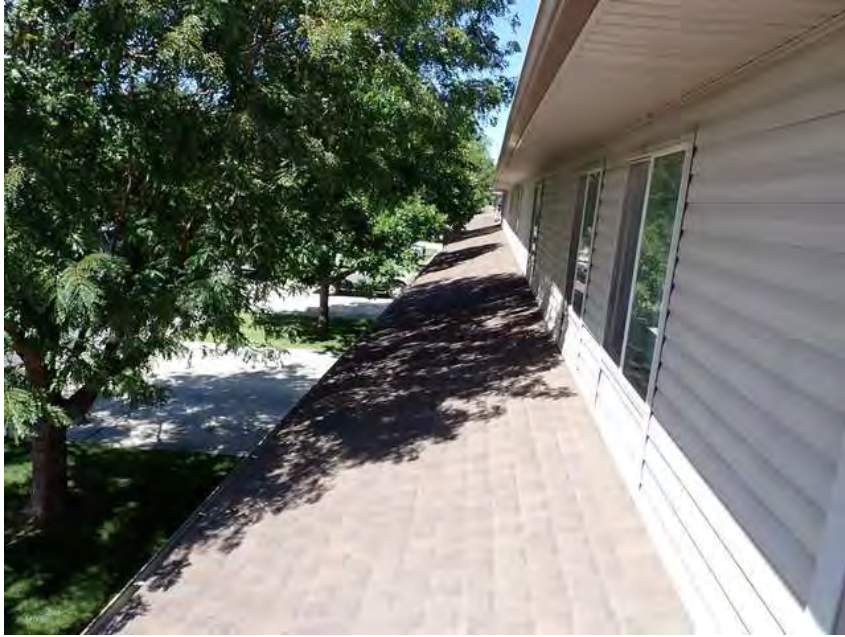
174. Building 10. Repair.

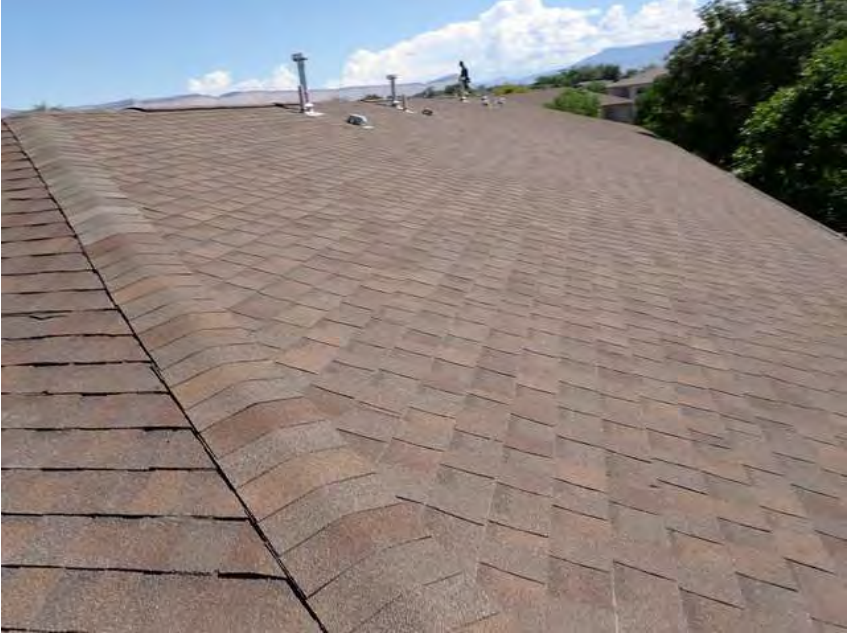
178. Building 10. Repair.

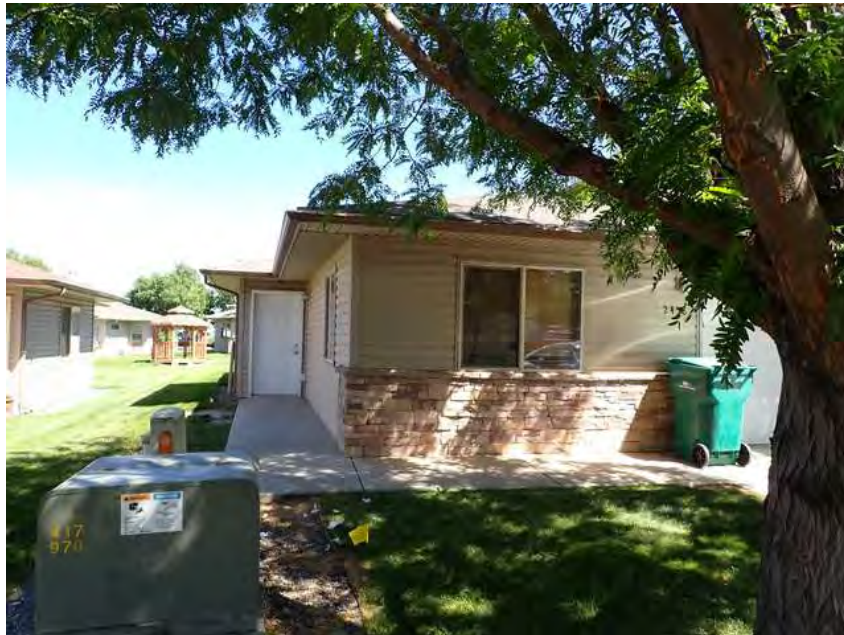
181. Building 10. Manufacturing anomaly.

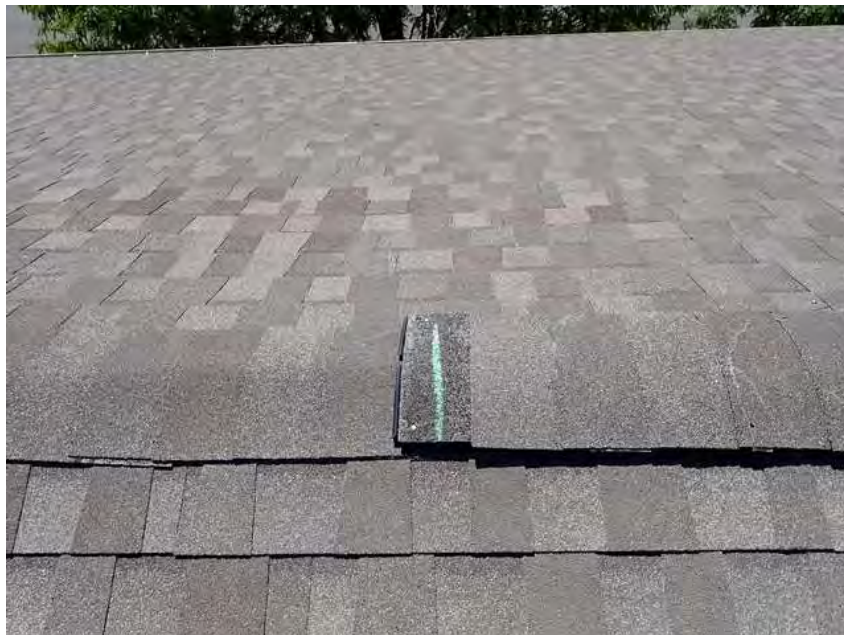
193. Building 11. Repair to ridge cap with cut shingles.

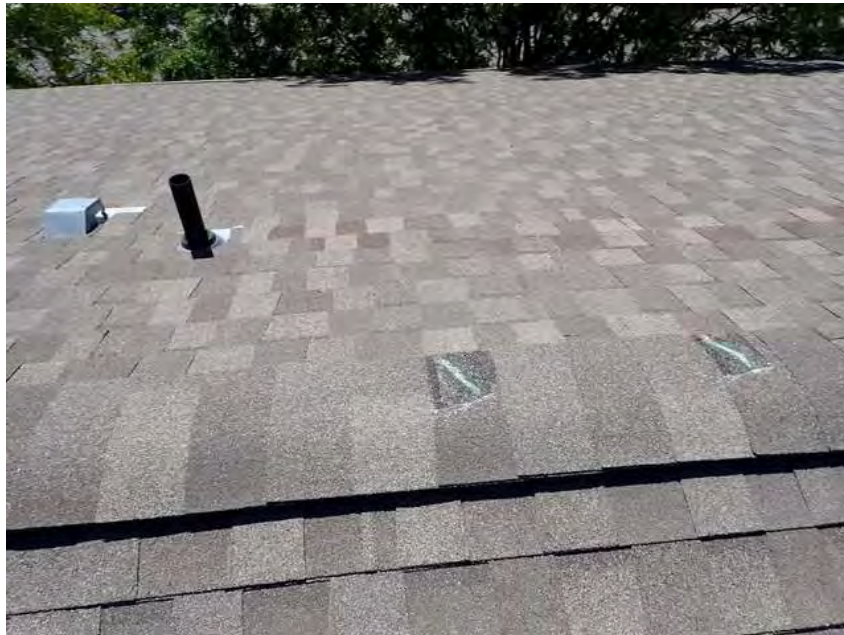
194. Building 11. Missing ridge cap.

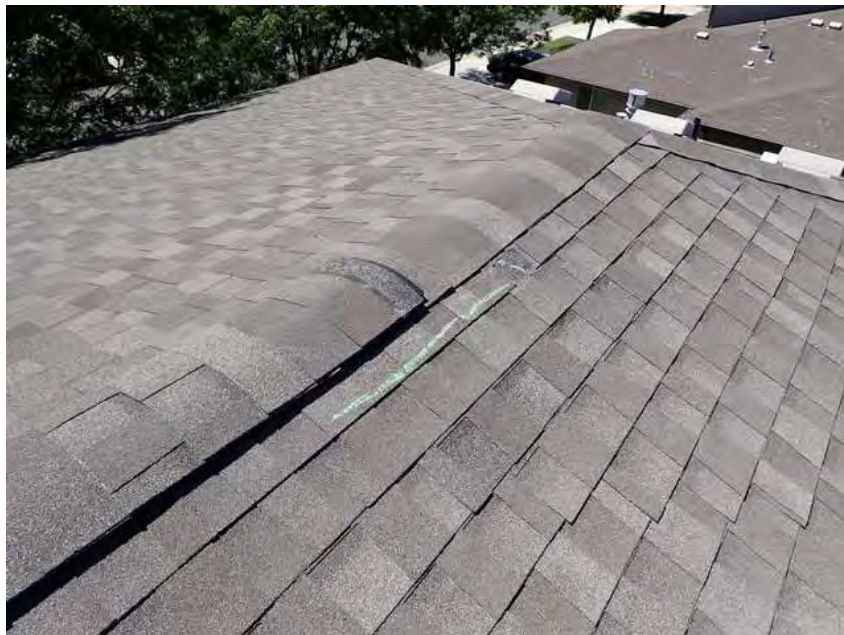
195. Building 11. Torn ridge caps.

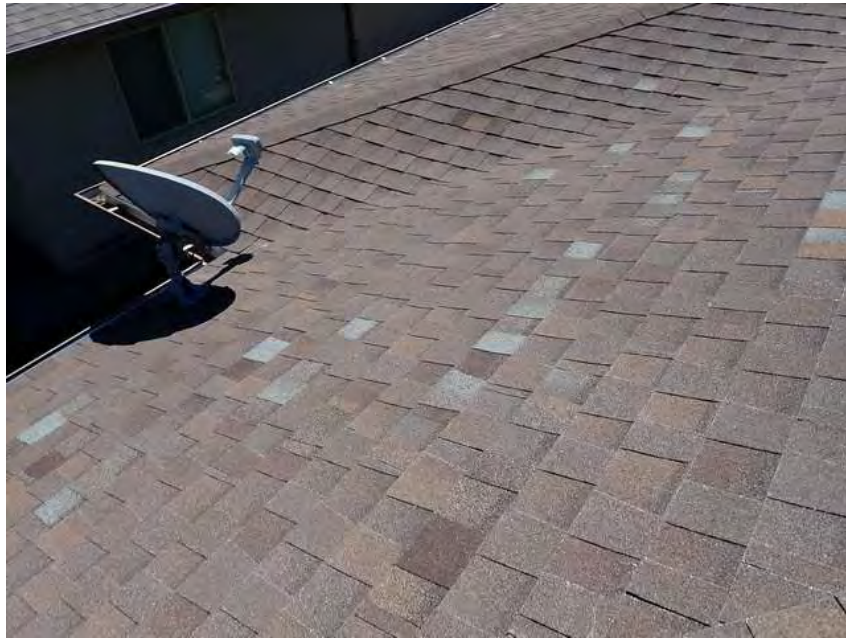
202. Building 12. Found shingles.

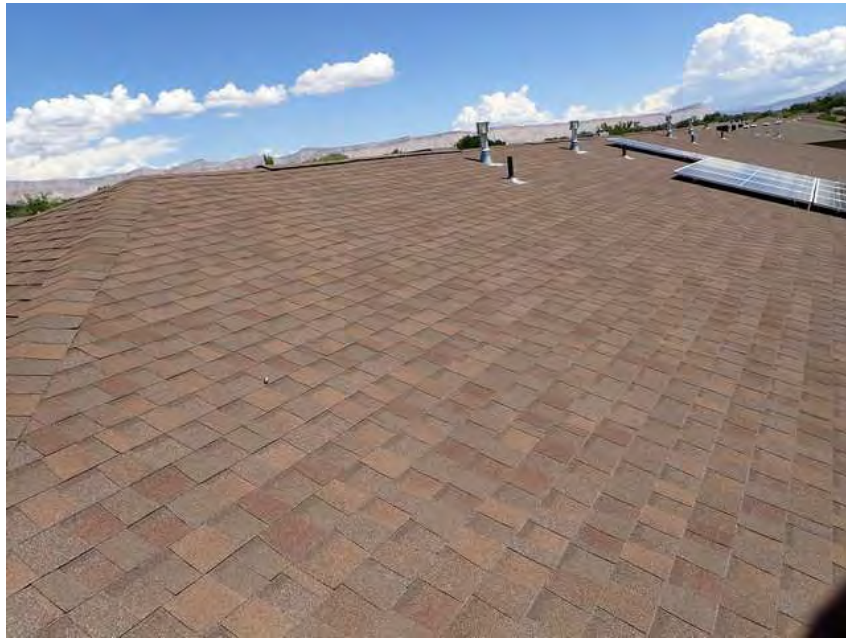
208. Building 12. Dormer unique to this building.

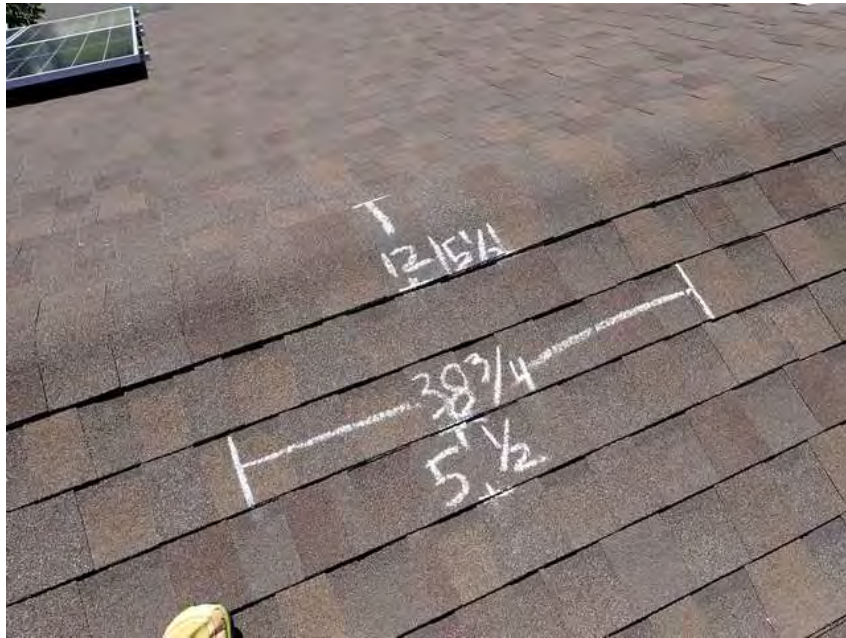
216. Building 12. Repair.

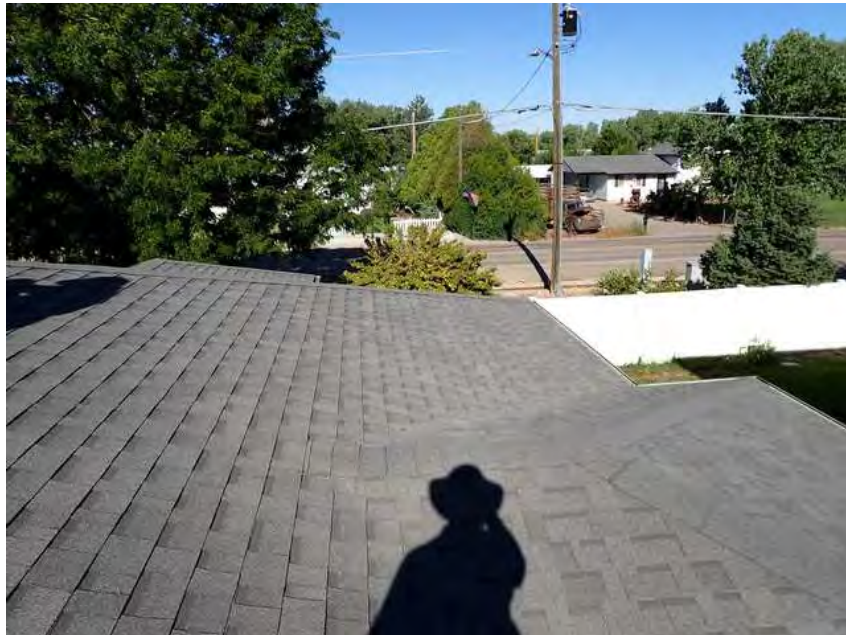
229. Building 13. Repair.

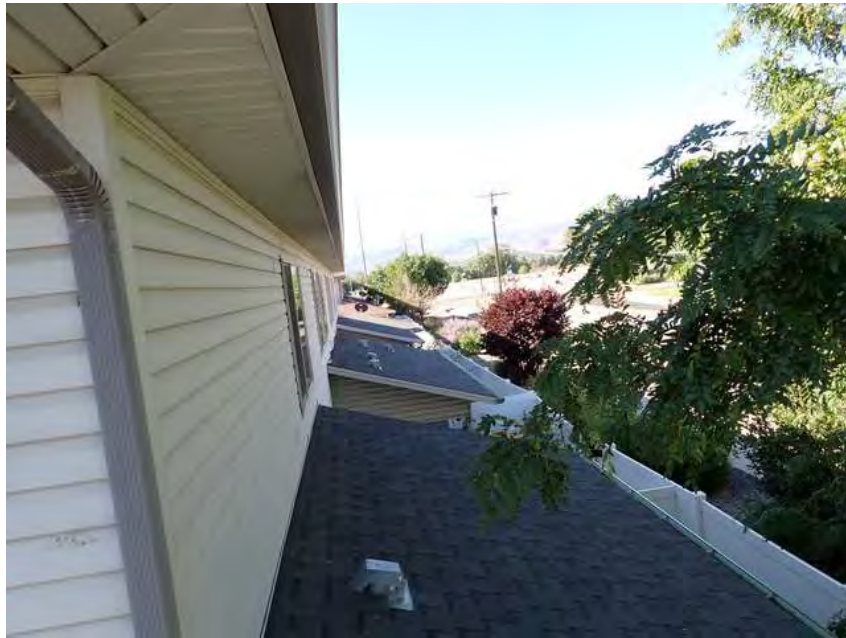
232. Building 13. Painted siding.

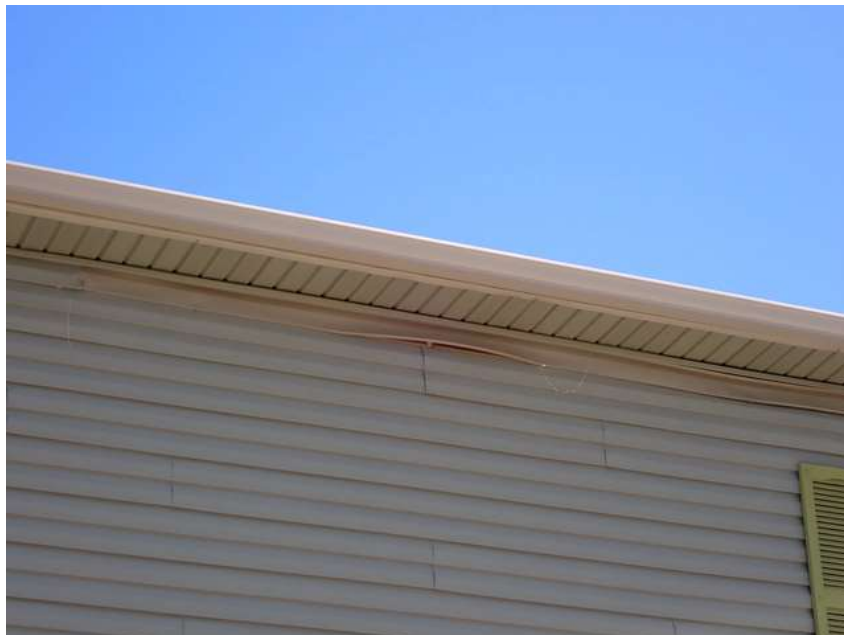
334. Building 20. Deformation in siding.

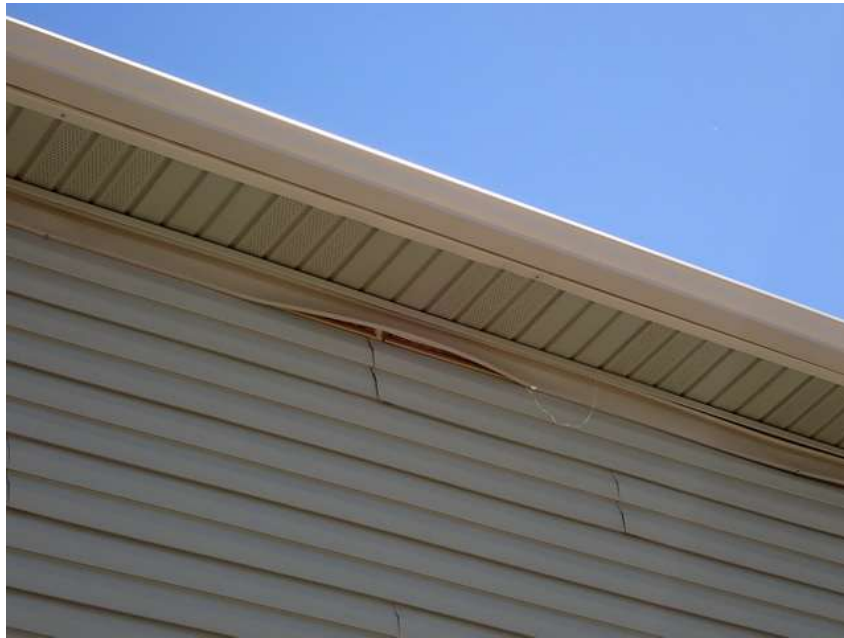
335. Building 20. Deformation in siding.

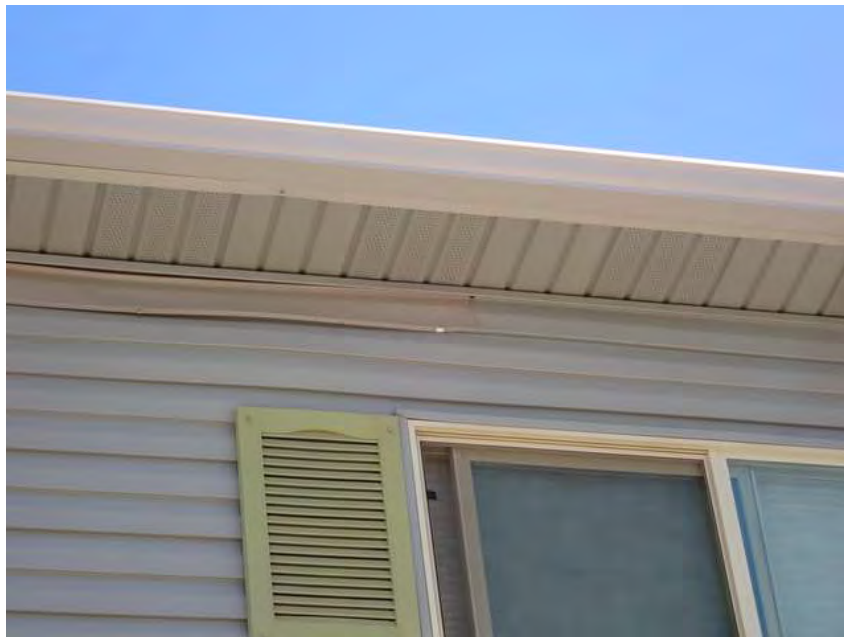
336. Building 20. Deformation in siding.

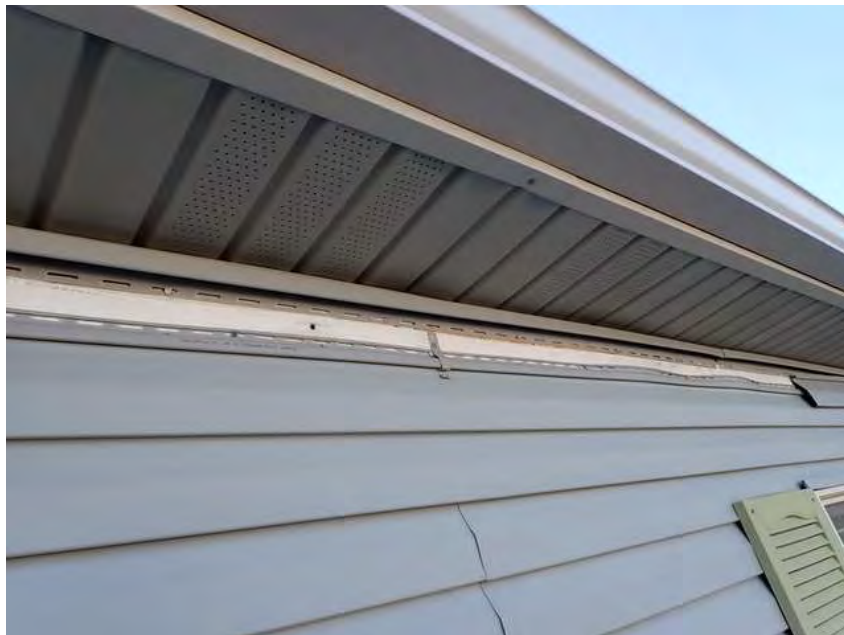
348. Building 20. Missing siding.

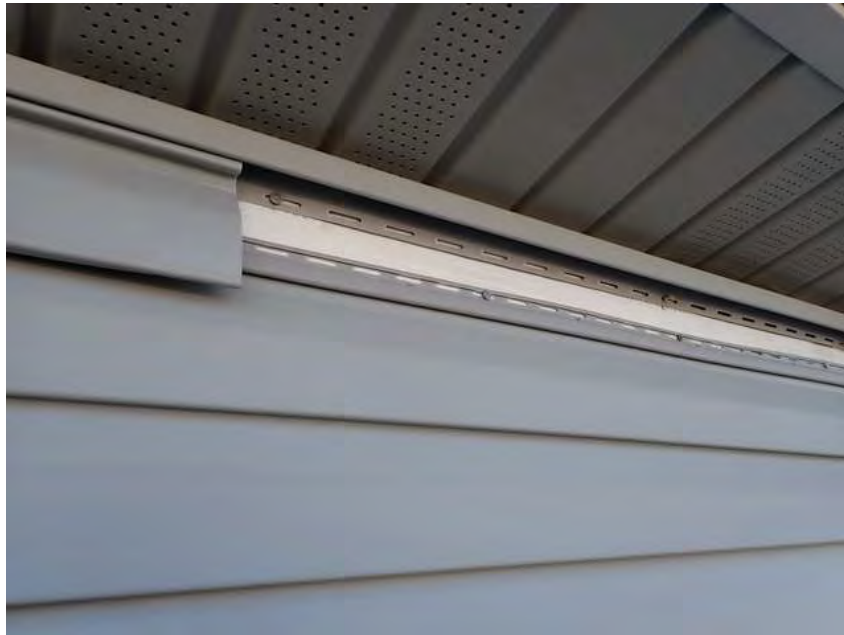
349. Building 20. Missing siding.

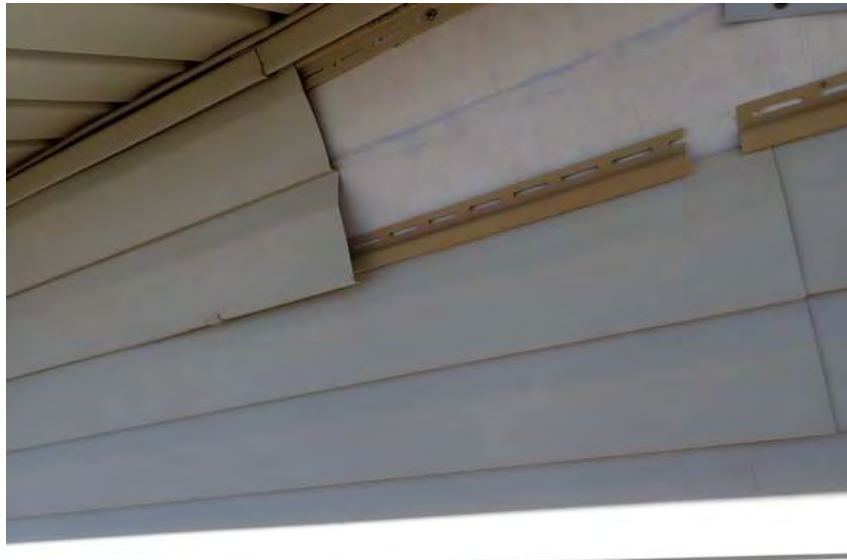
371. Building 22. Missing siding.

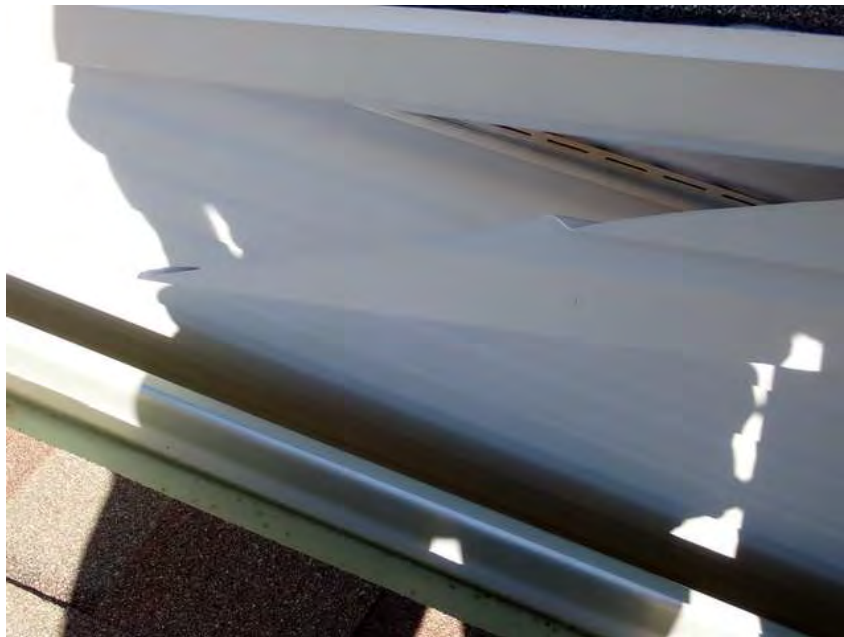
374. Building 22. Displaced siding.

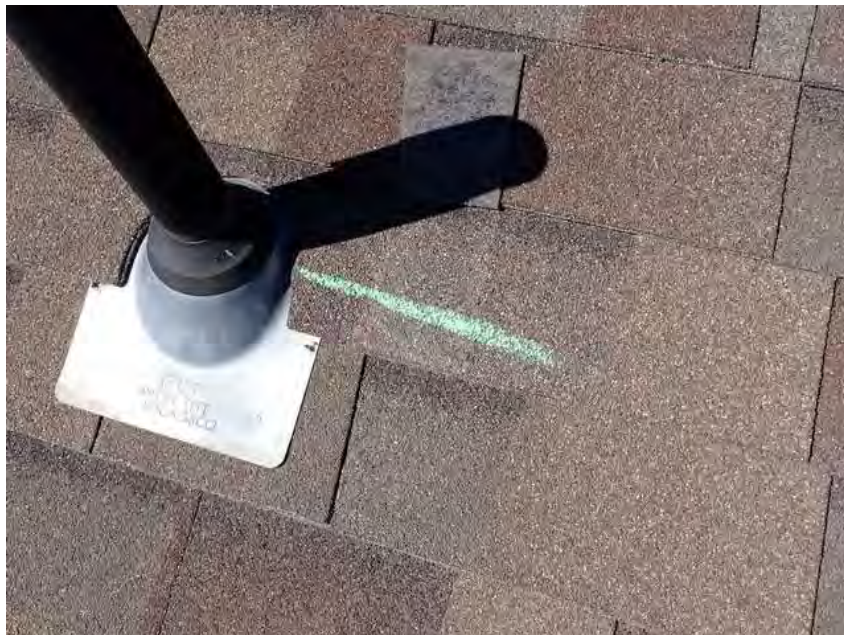
382. Building 22. Creased tooth on shingle.

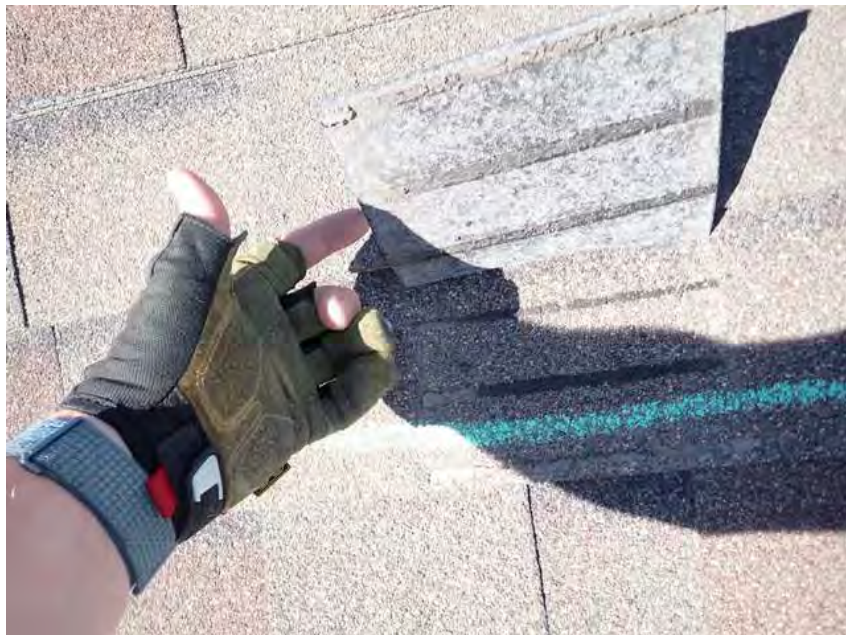
384. Building 22. Creased tooth on shingle.

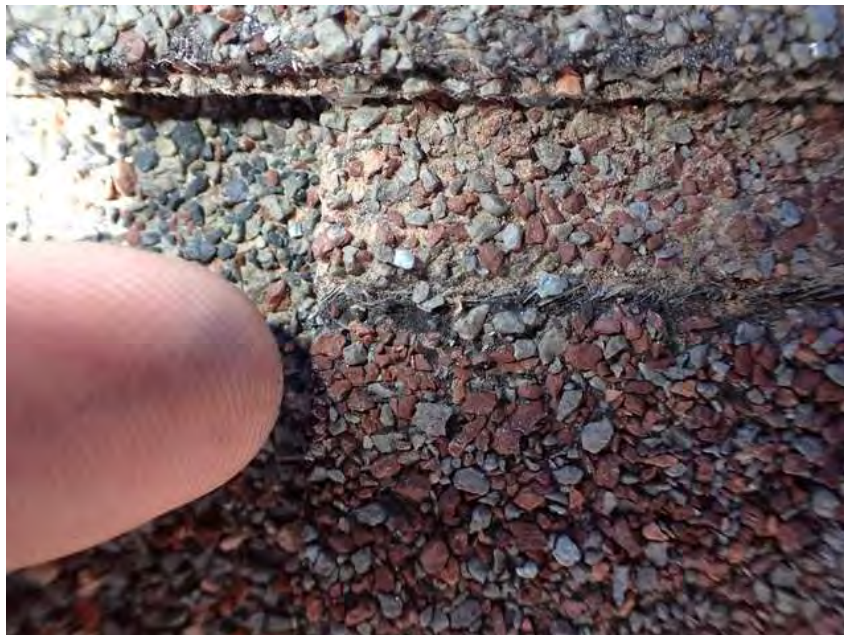
386. Building 22. Detail of crease.

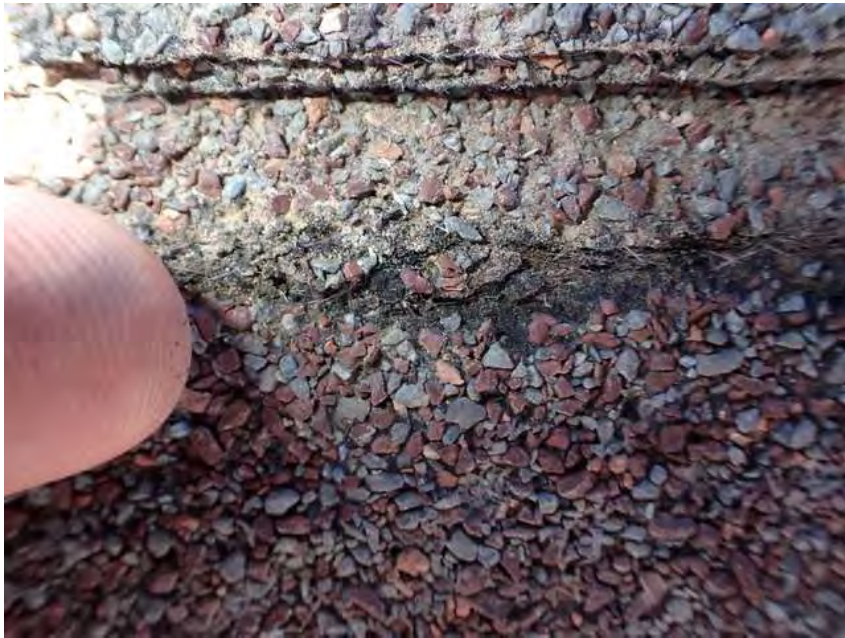
387. Building 22. Detail of crease.

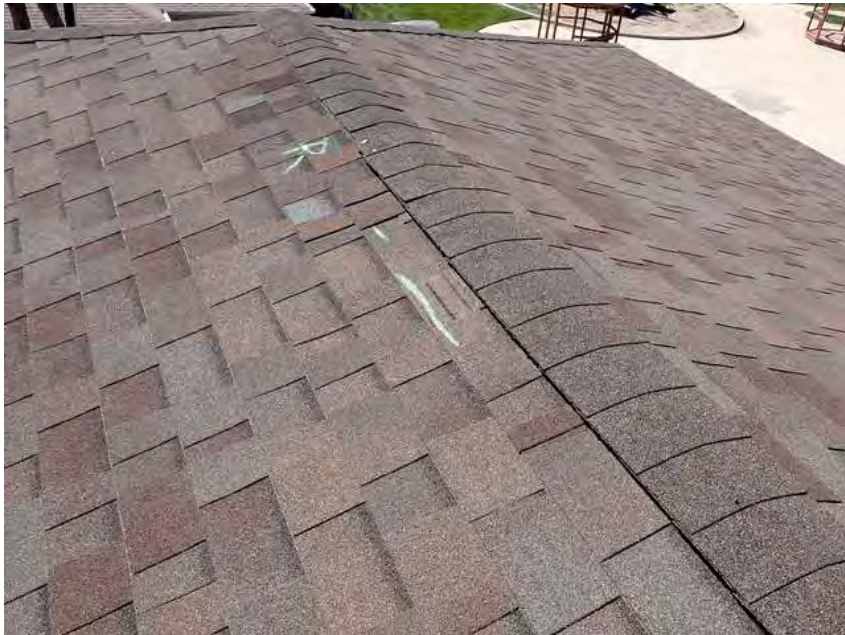
388. Building 22. Missing tooth on shingle.
