Brookwillow Village HOA
Building Elevation and Roof Evaluation
2450 1/2 Ajay Avenue
Grand Junction, CO 81505
Client File: 124830-1
Haag File: 12240428CO-1855/254

October 8, 2024

Re: Brookwillow Village HOA
Building Elevation and Roof Evaluation
2450 1/2 Ajay Avenue
Grand Junction, CO 81505
Client File: 124830-1
Haag File: 12240428CO-1855/254

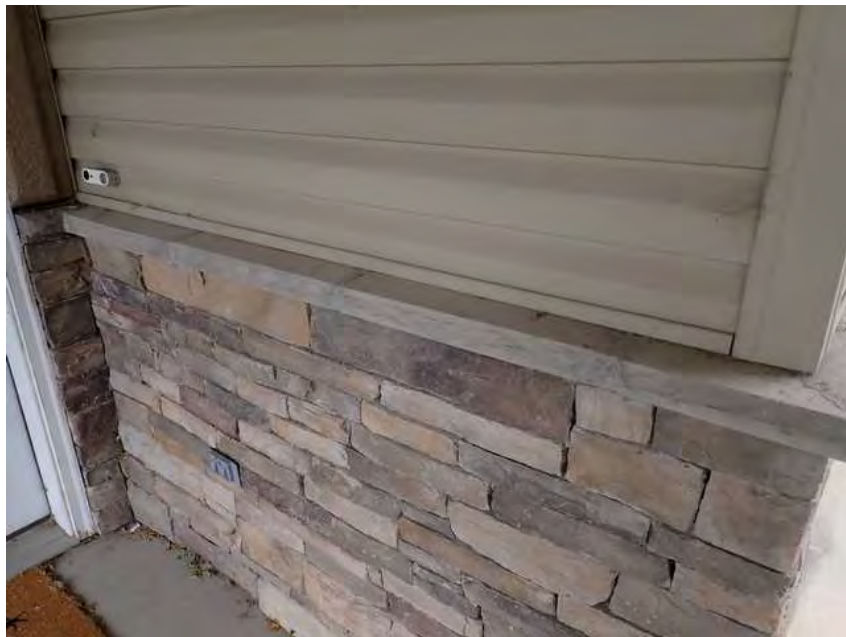
2. Building 1. Cultured stone veneer.

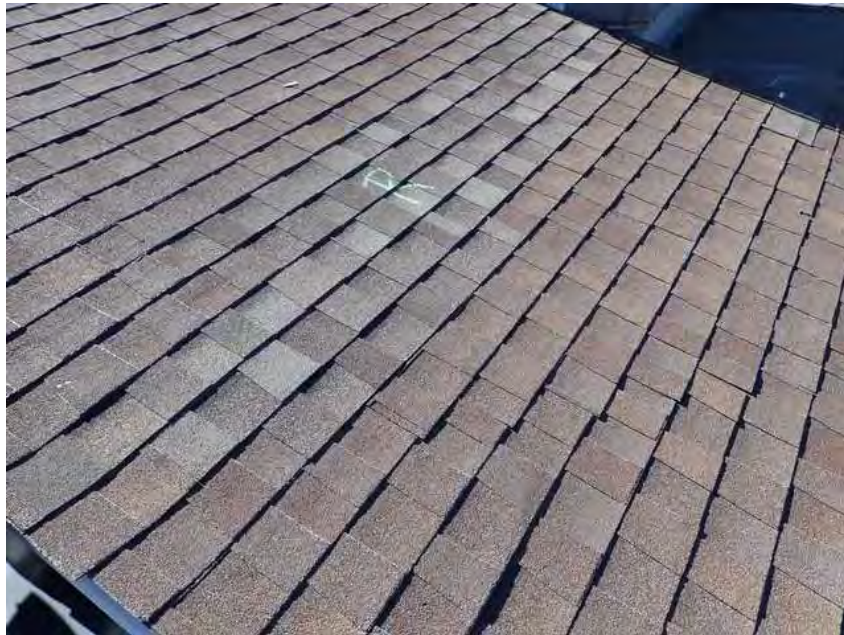
14. Building 1. Repair.

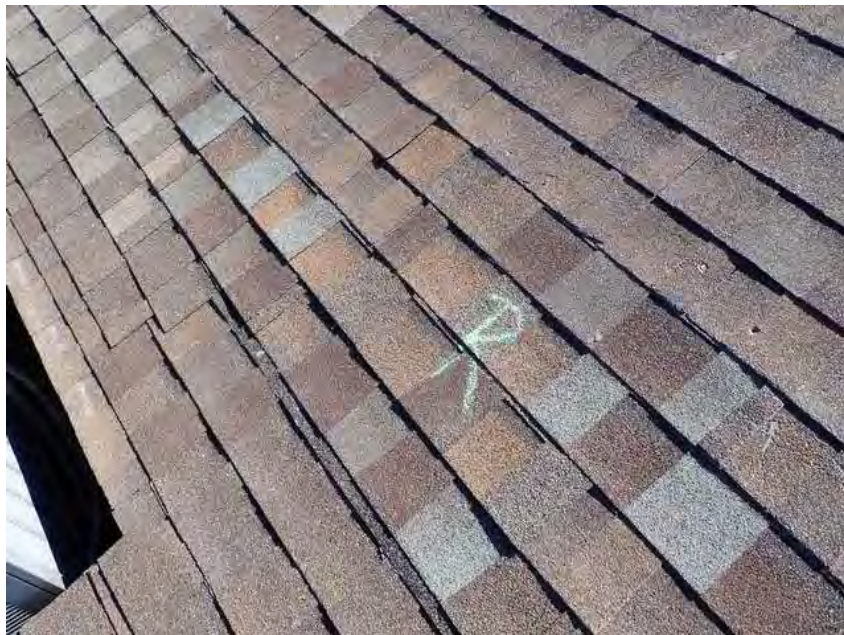
22. Building 1. Repair.

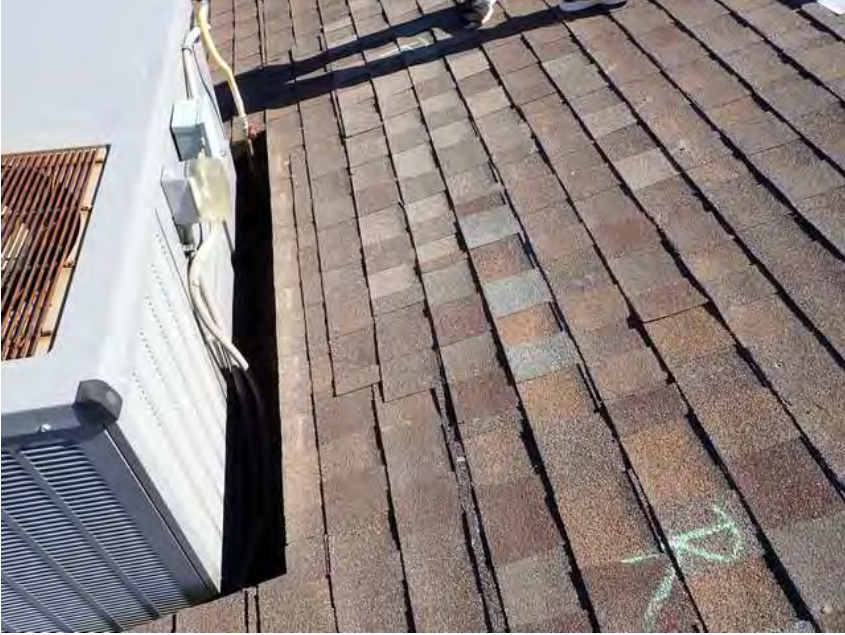
23. Building 1. Repair.

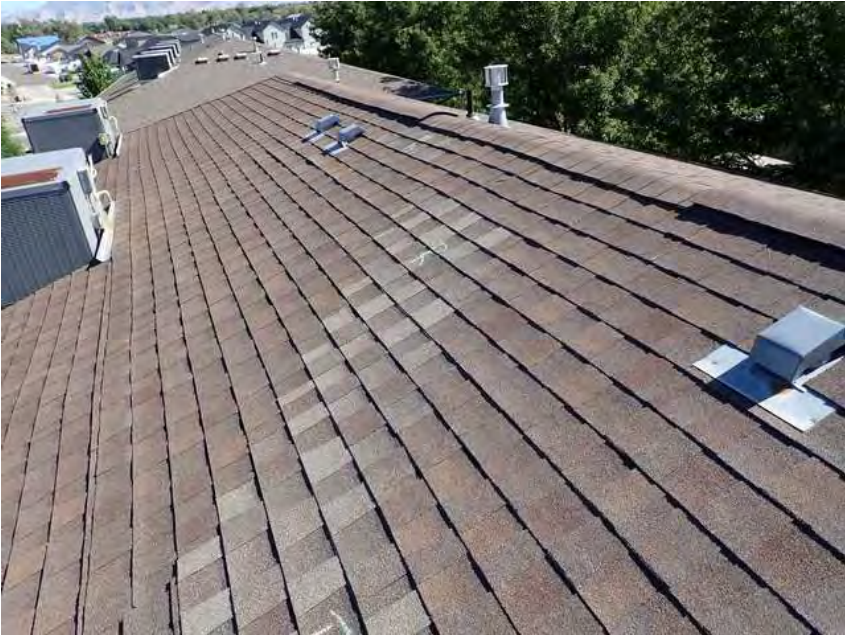
24. Building 1. Repair.

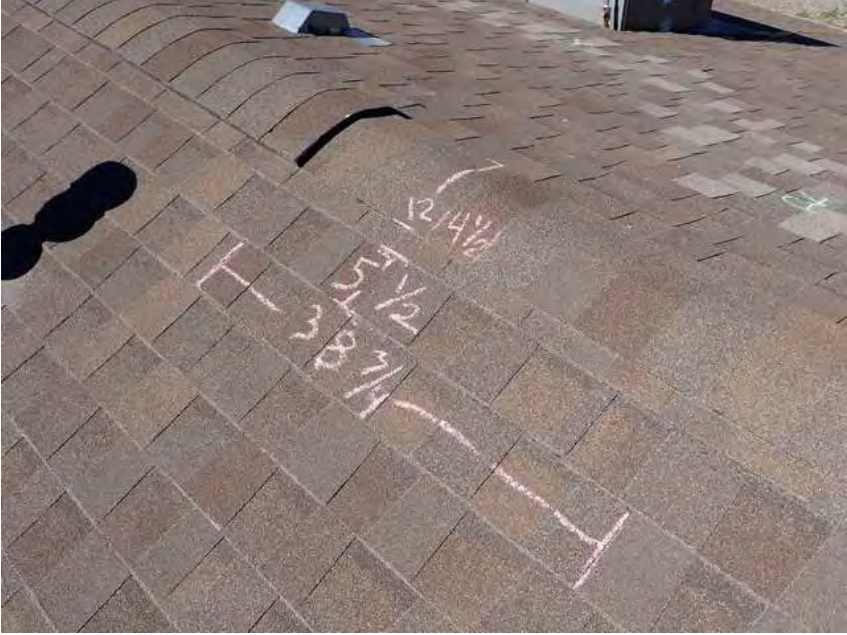
25. Building 1. Dimensions of primary shingle.

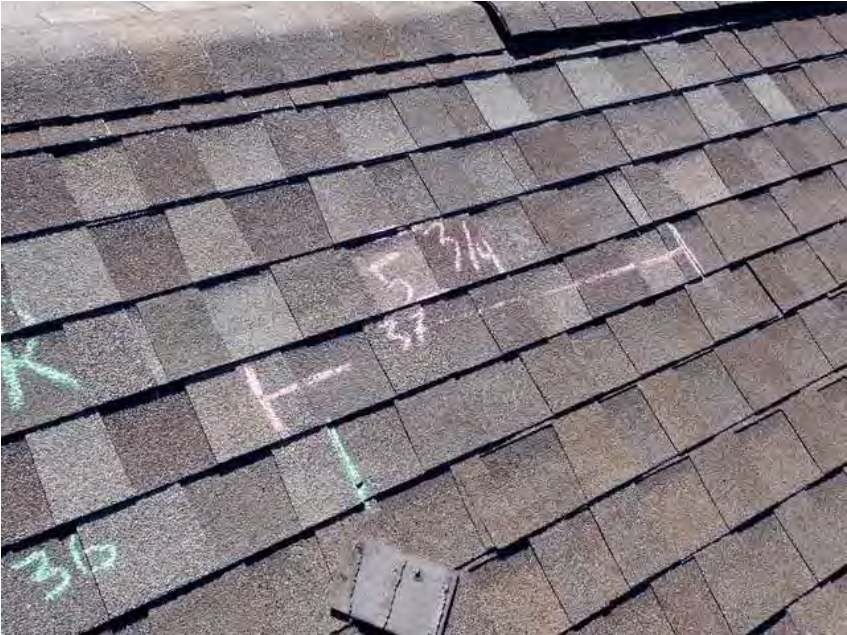
26. Building 1. Dimensions of repair shingles.

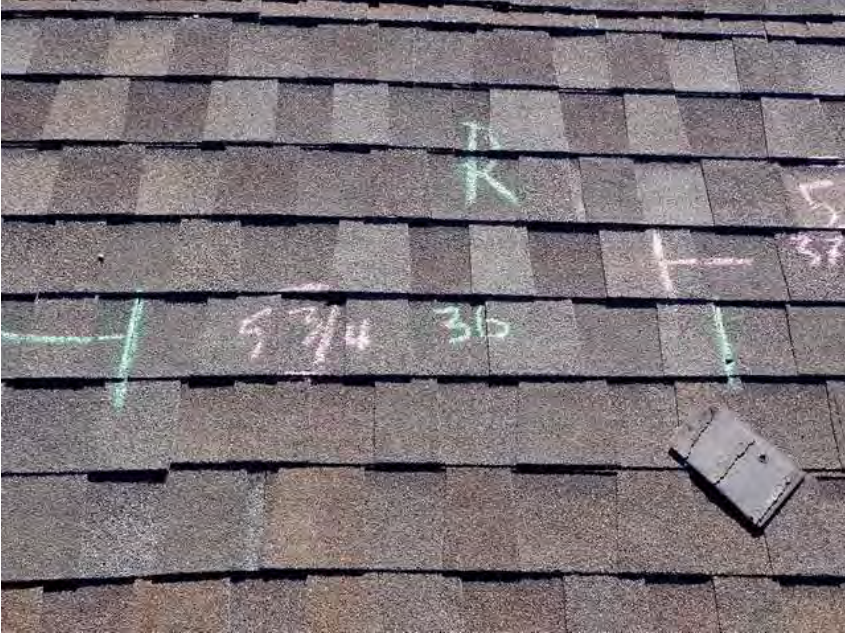
27. Building 1. Dimension of repair shingles.

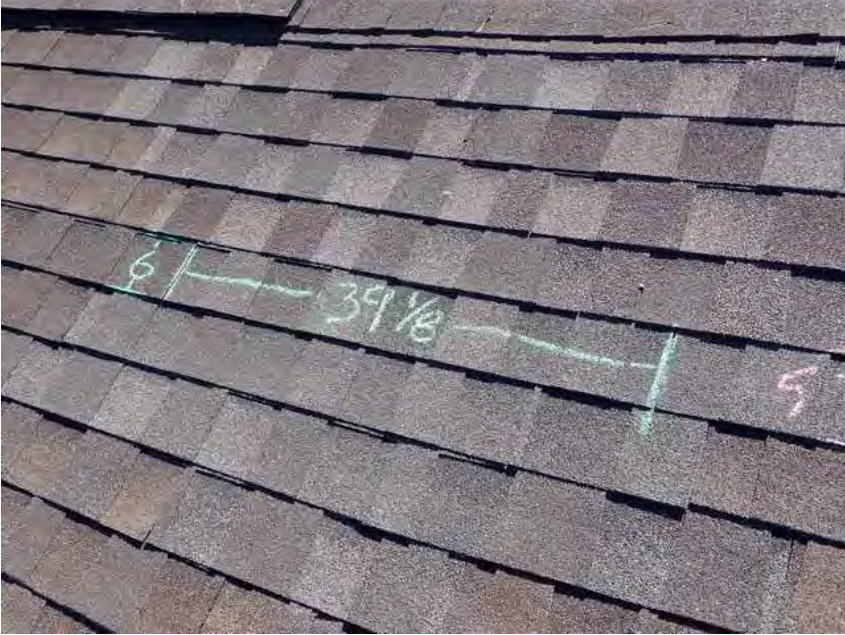
28. Building 1. Dimension of repair shingles.

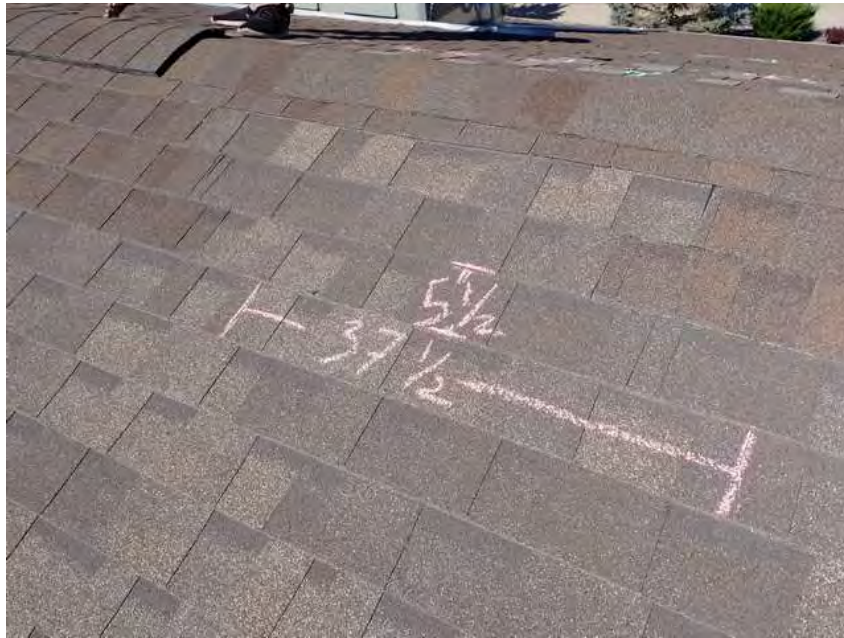
29. Building 1. Dimension of repair shingles.

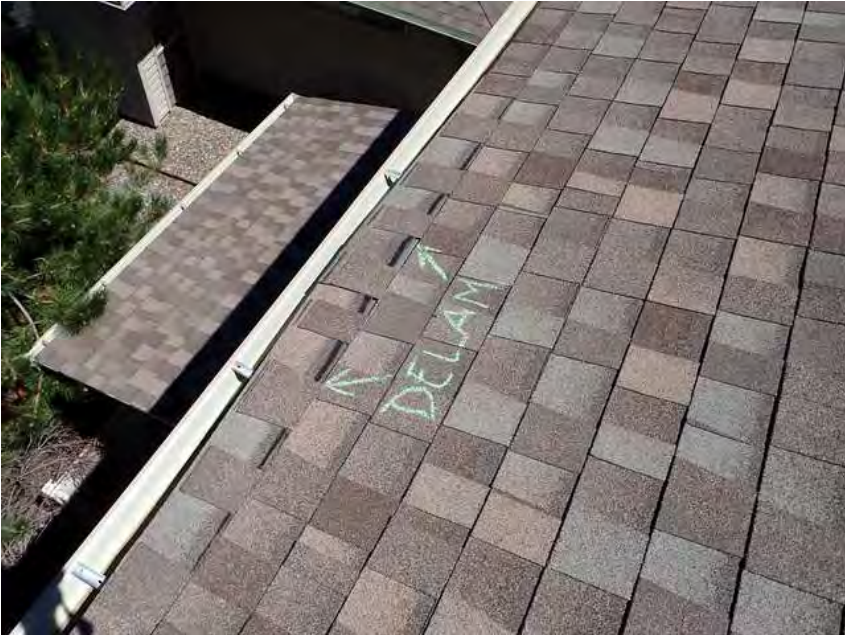
56. Building 3. Delamination.

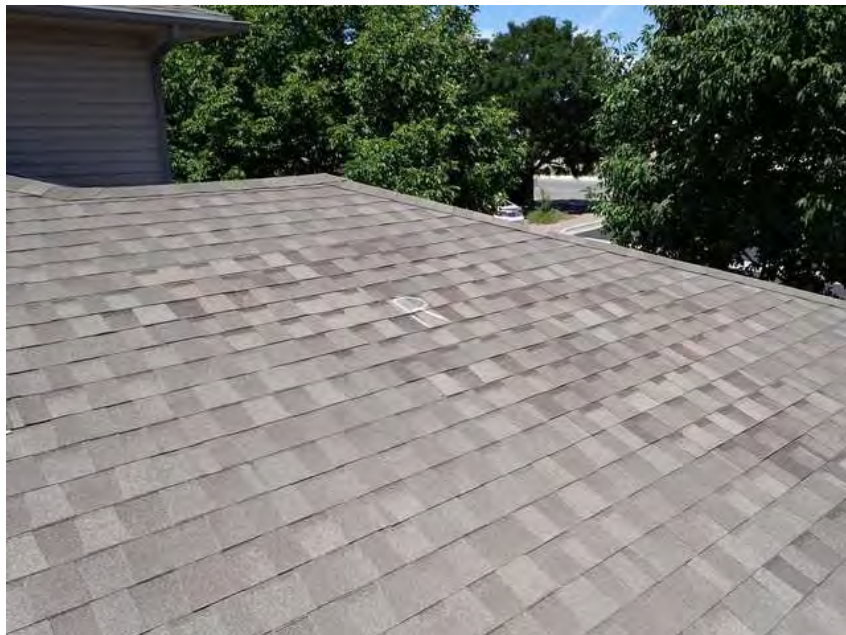
64. Building 4. Repair.

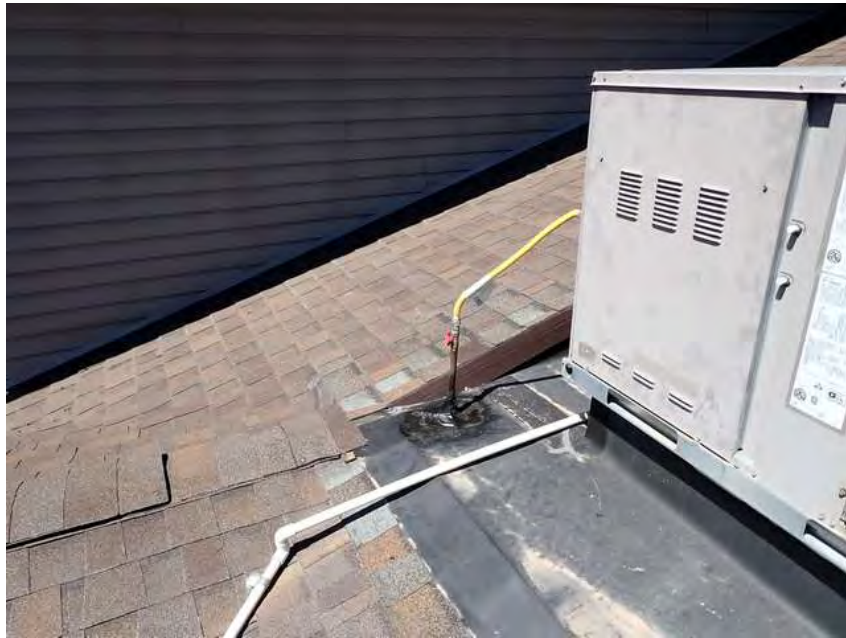
99. Building 6 Repair.

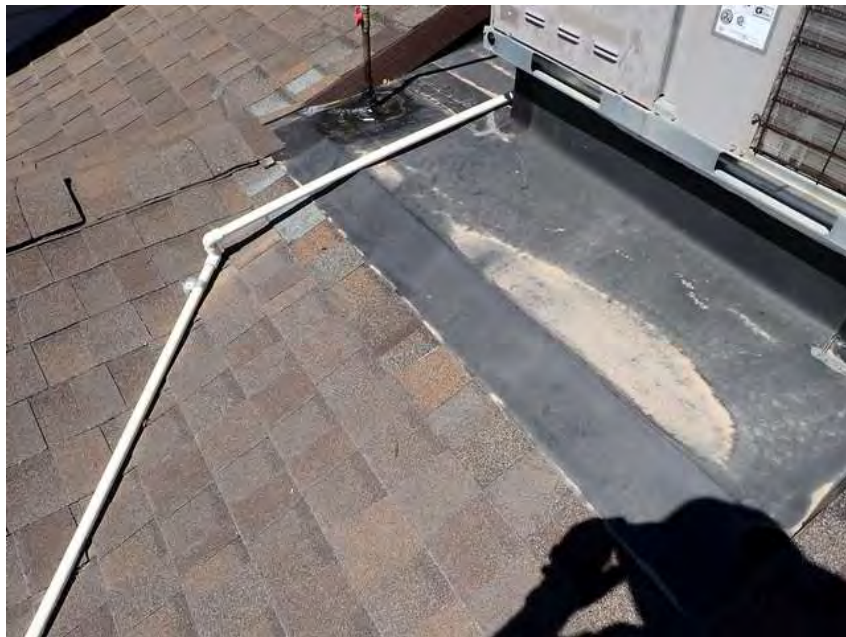
100. Building 6 Repair.

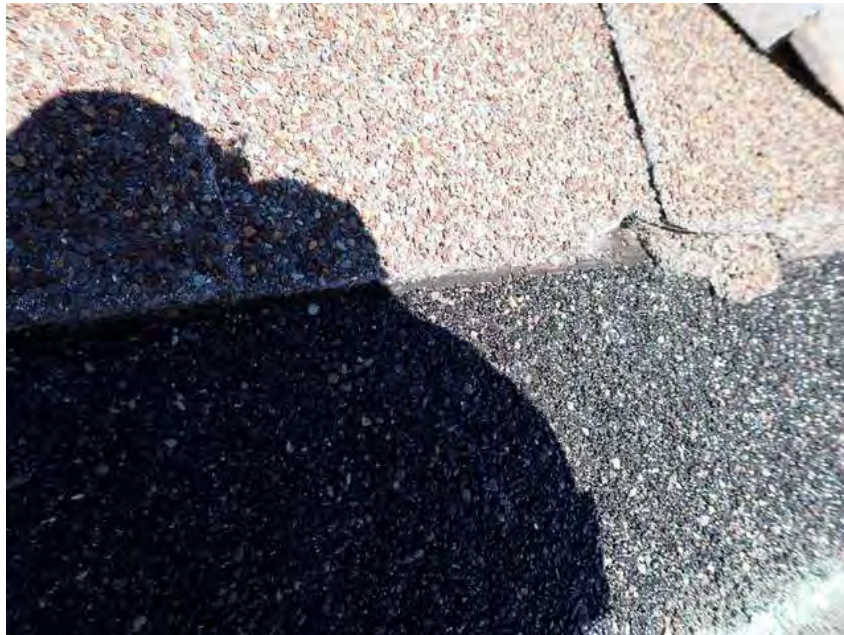
110. Building 6 Fresh black binder suggests a recent event.

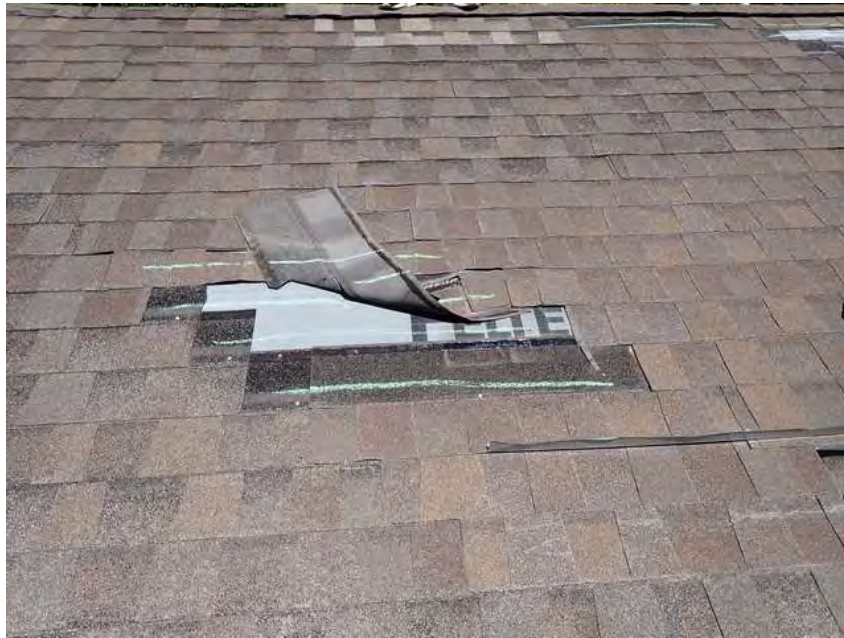
113. Building 6 Three shingles affected by recent winds.

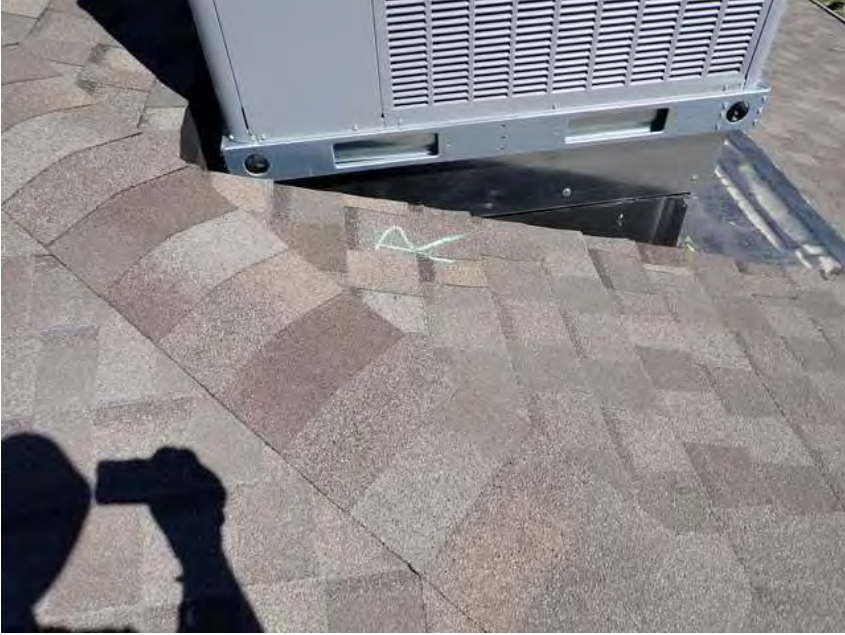
149. Building 8. Repair.

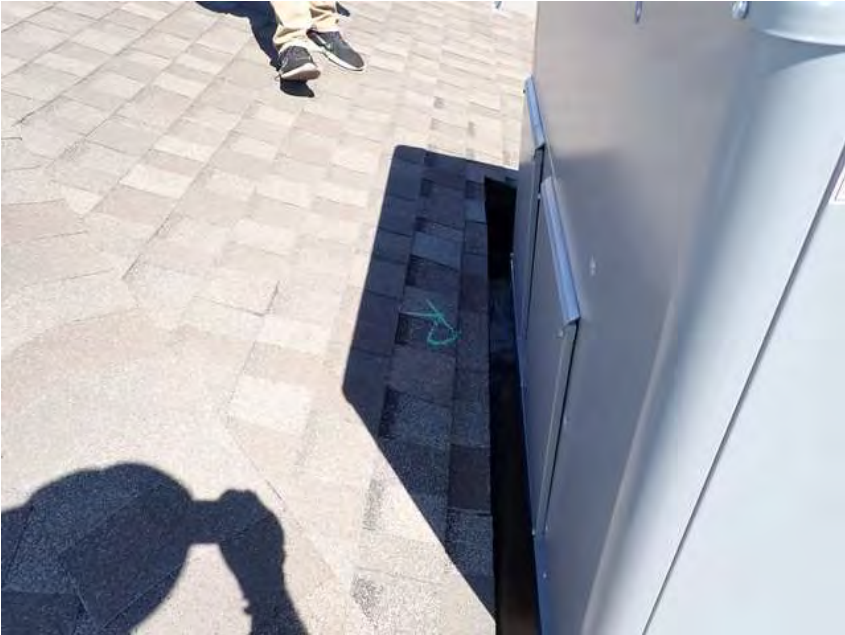
150. Building 8. Repair.

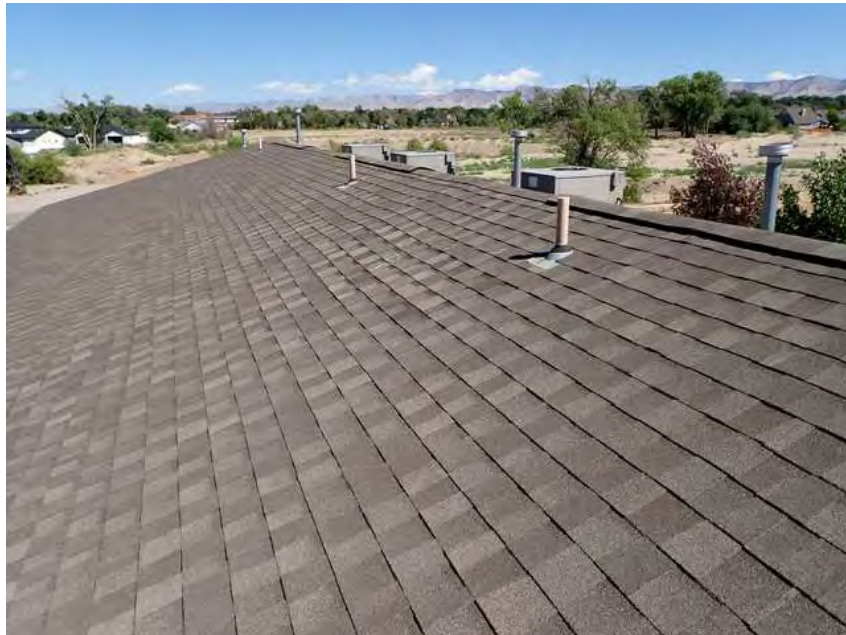
152. Building 8. Repair.

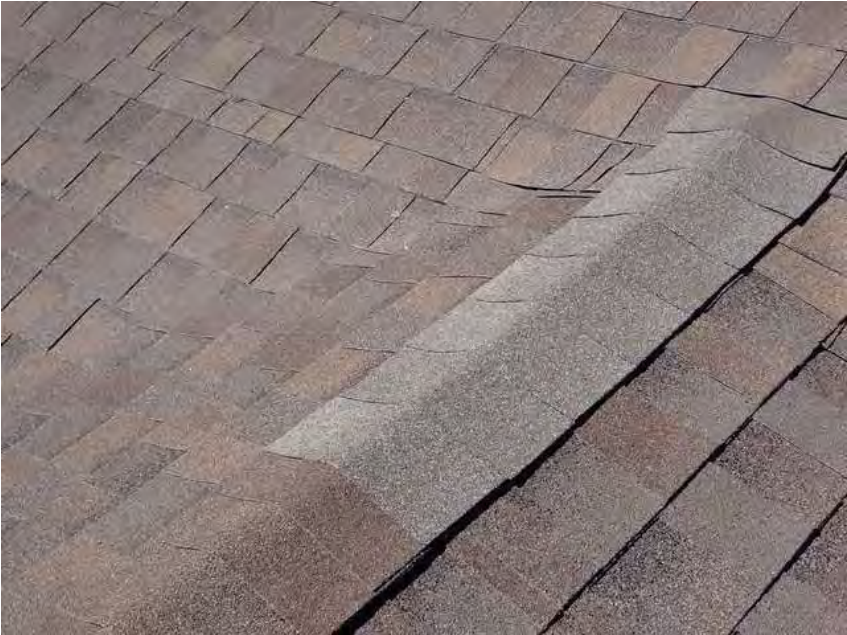
173. Building 10. Repair.

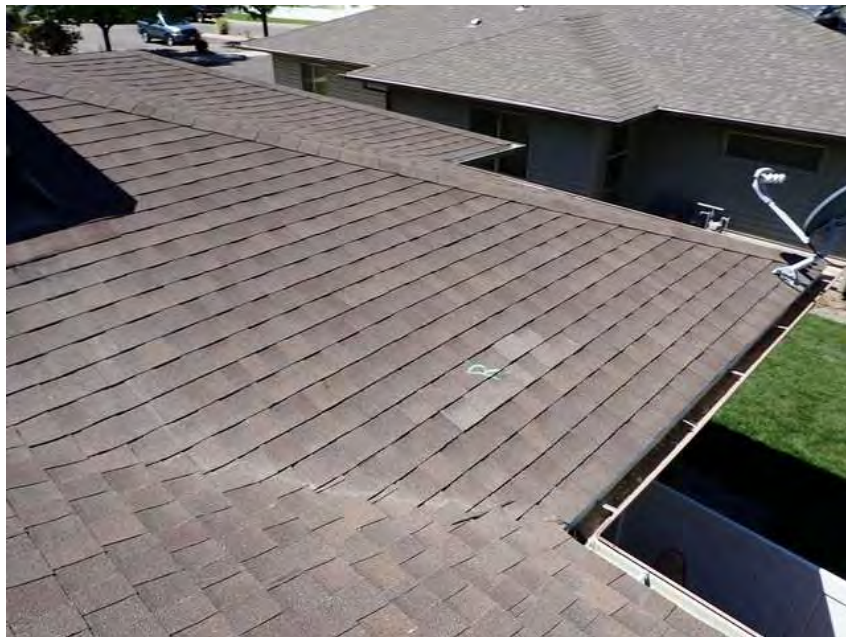
177. Building 10. Repair.

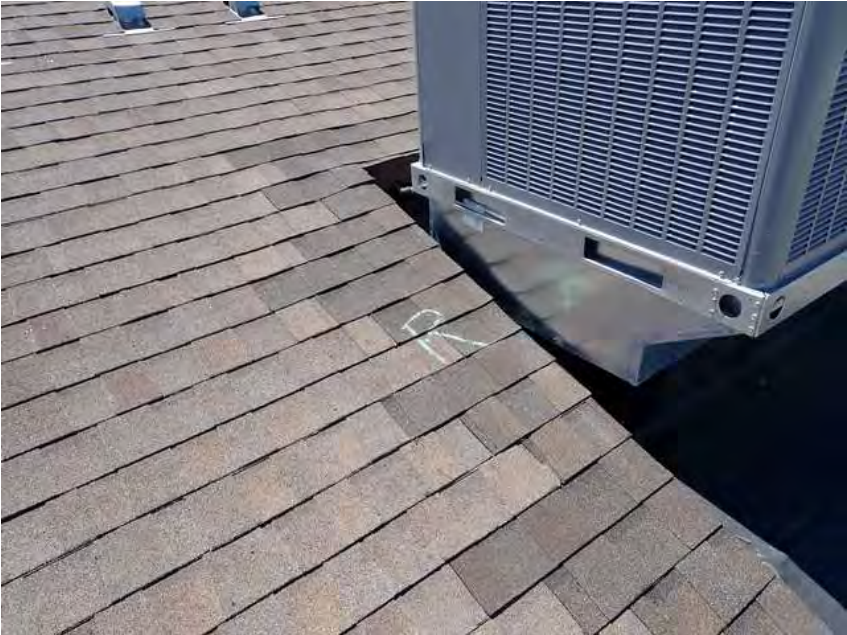
213. Building 12. Repair.

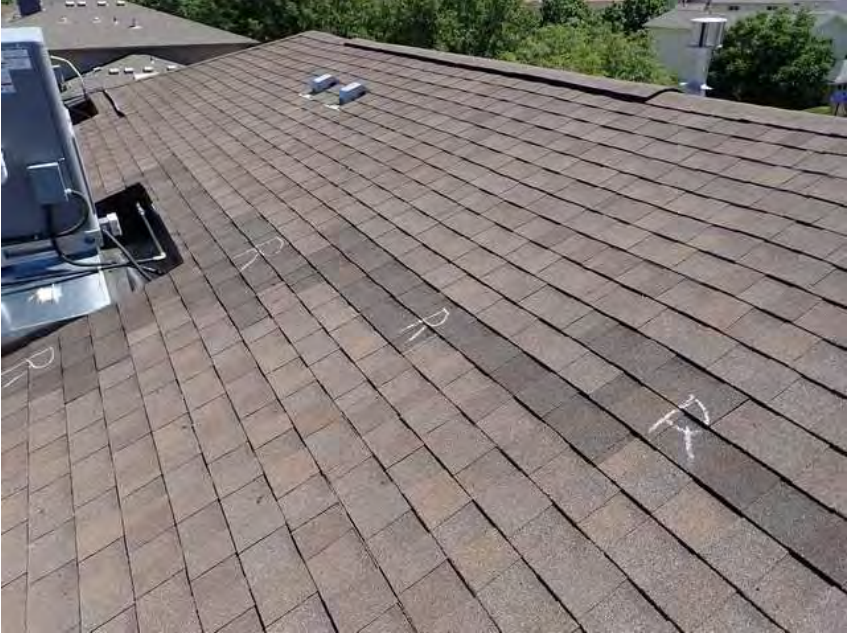
214. Building 12. Repair.

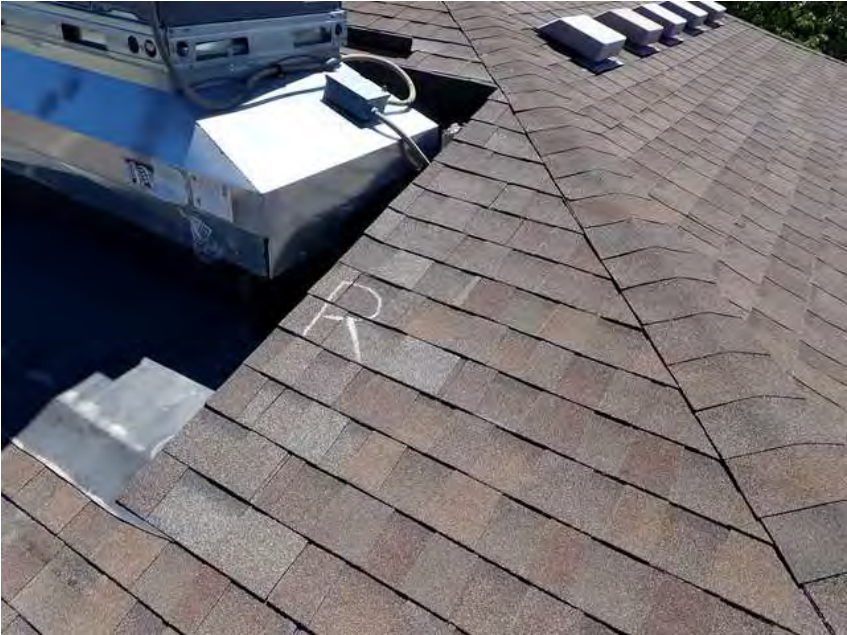
215. Building 12. Repair.

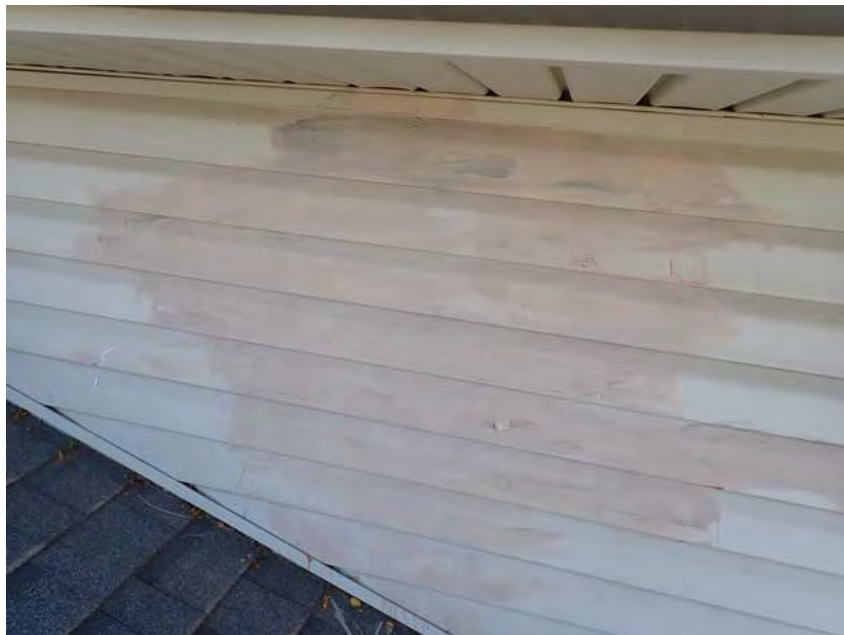
231. Building 13. Painted siding.

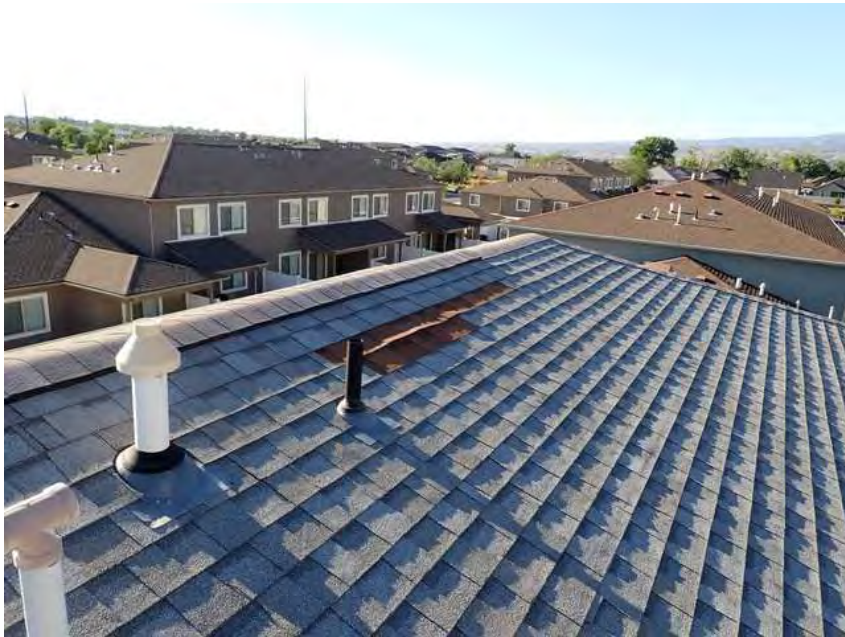
344. Building 20. Repair.

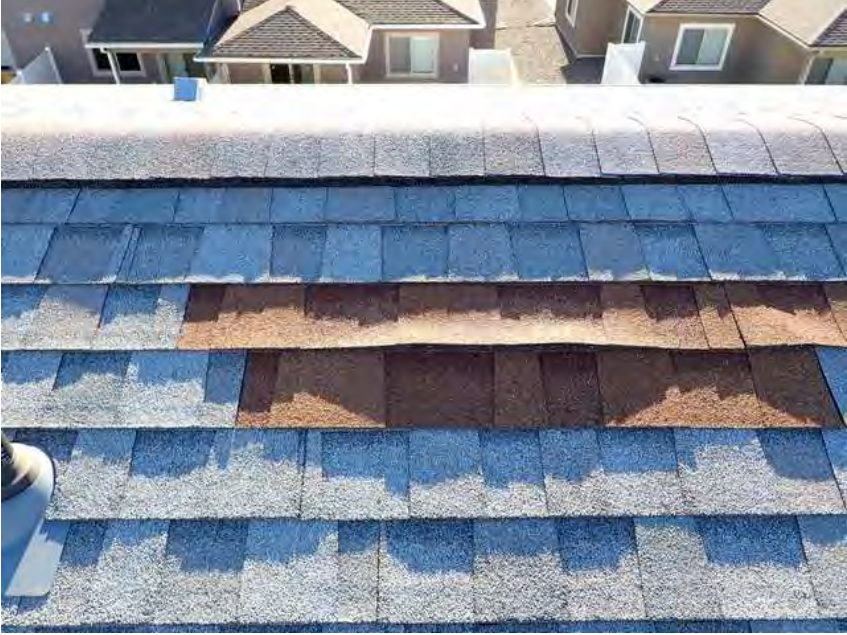
345. Building 20. Repair.

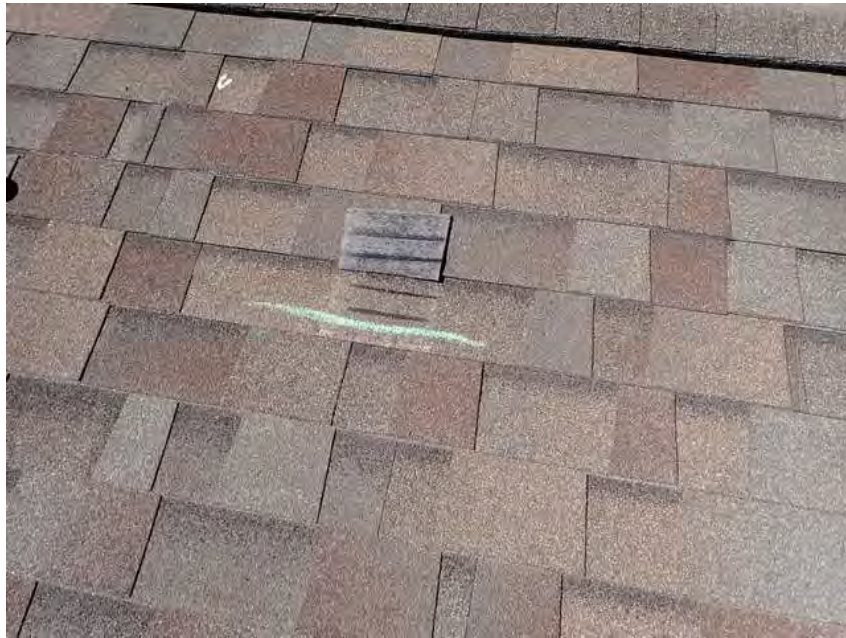
383. Building 22. Creased tooth on shingle.

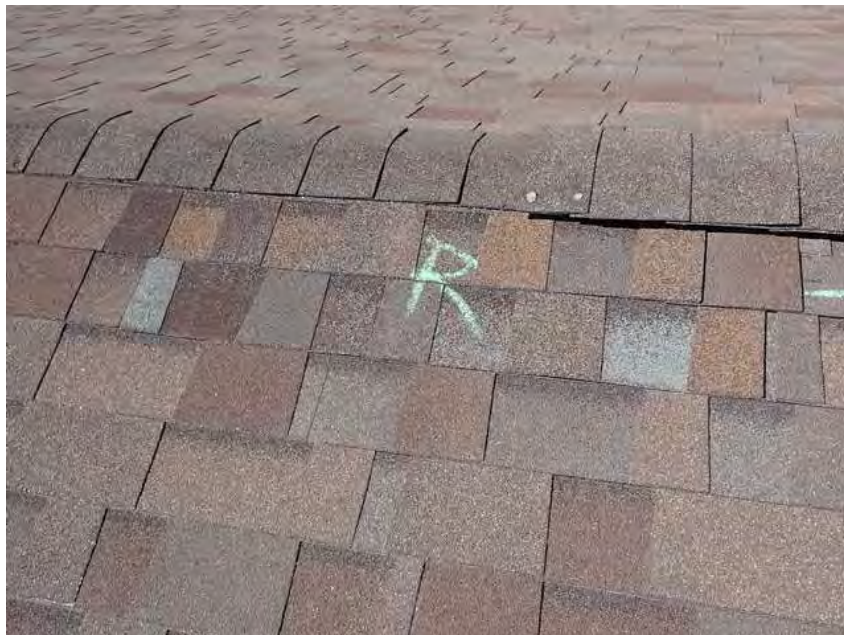
390. Building 22. Repair.
